Loss of control involving Robinson R44, VH-WOH

20 km south-west of Mudgee, New South Wales | 9 December 2012

ATSB Transport Safety Report
Aviation Occurrence Investigation
AO-2012-165
Final – 26 September 2013

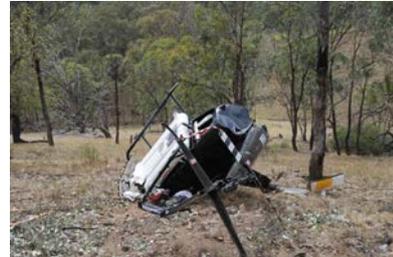
Helicopter wreckage

On 9 December 2012, the pilot of a Robinson R44 Raven I helicopter, registered VH-WOH, was conducting aerial spraying activities on a property near Mudgee, New South Wales. Following the completion of a number of spray runs, the helicopter failed to return to the refilling station, and a search was commenced. The helicopter was found about 450 m up a hill from the refilling station, having collided steeply with terrain. The pilot was fatally injured.

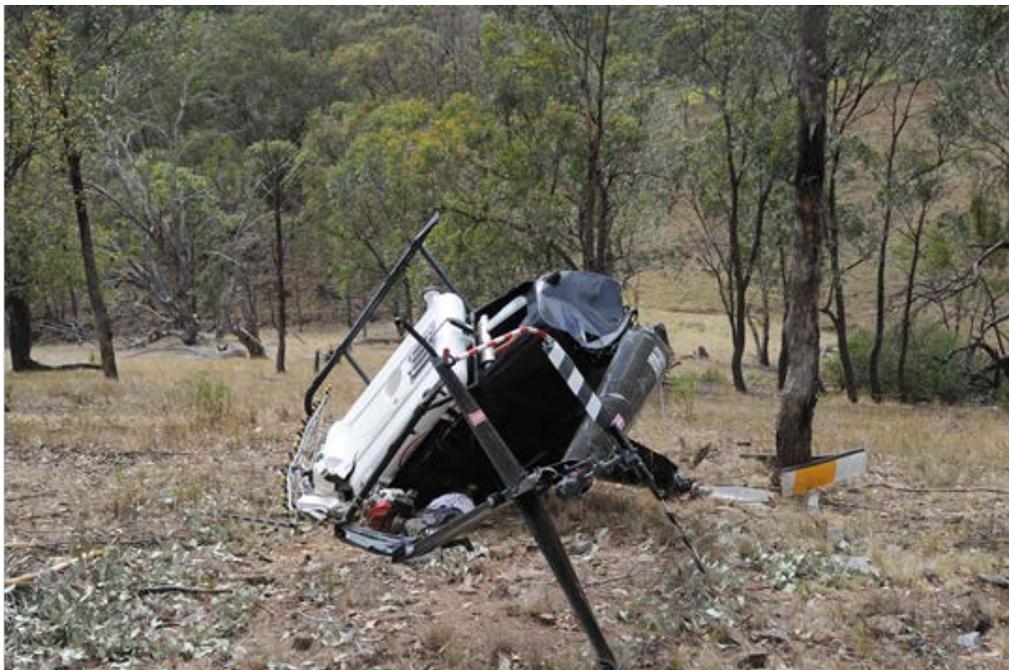
At about 1015 the loader and neighbouring property owner became concerned that the helicopter had not returned and, along with the property owner, initiated a search. At about 1100, the helicopter was found on steep terrain about 450 m from the refilling station. The damage to the helicopter and disturbance of the surrounding area indicated that the helicopter contacted a tree before impacting the ground in a steep nose-down attitude with the right skid low (Figure 2, 3 and 4). The pilot was fatally injured and the helicopter seriously damaged.² There was no fire.

Figure 3: Accident site showing the helicopter's position at ground impact

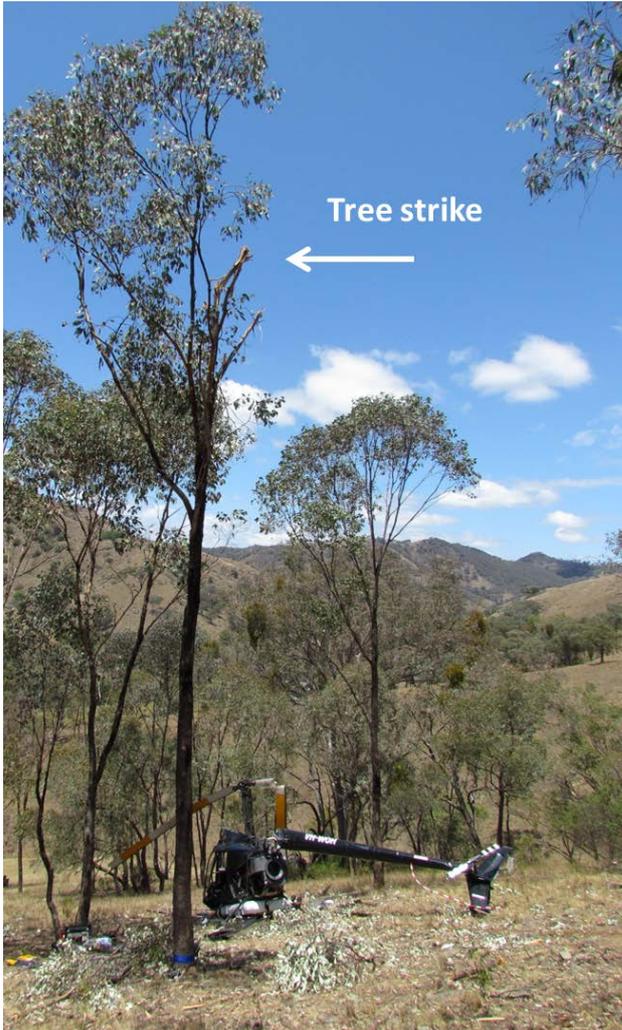
Figure 4: Tree strike and uprighted helicopter position, next to the ground impact point

The wreckage of the helicopter was situated on steep terrain that was inclined at a slope of about 23°. The damage to the helicopter and a nearby tree were consistent with the main rotor blades contacting tree branches before the helicopter collided steeply with terrain (Figure 5).

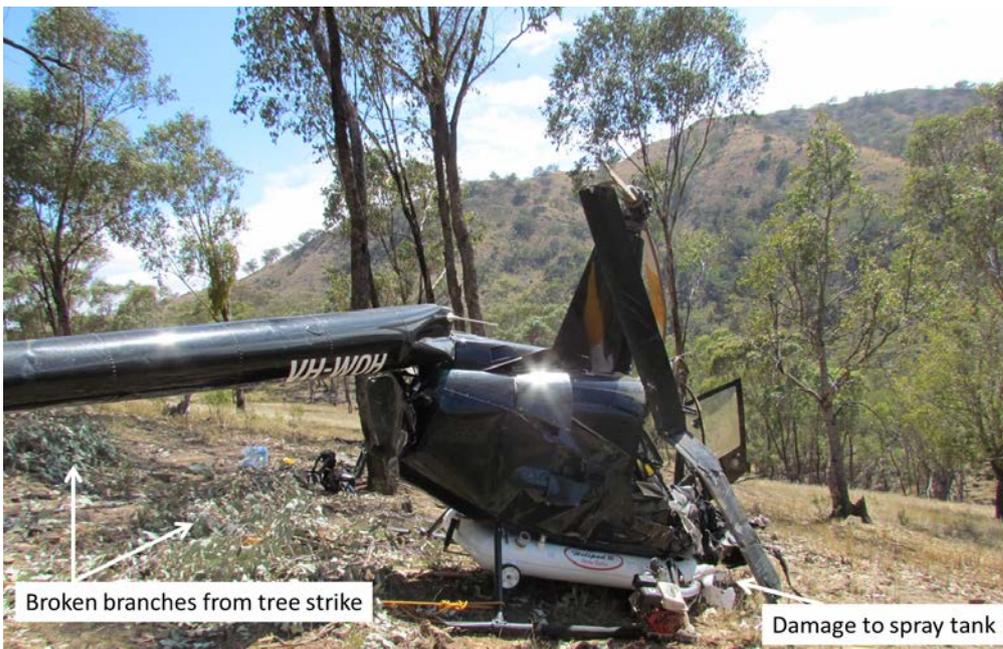
Figure 5: WOH (uprighted) showing the damage to the surrounding branches and helicopter's spray tank

The front right corner of the spray tank was ruptured during the impact sequence and the witness reported that on arrival at the accident site, there was no chemical load remaining in the tank and no evidence of chemical in the vicinity. This apparent contrast with the ATSB's assessment that the majority of chemical was on board at the time of the accident (see the previous section titled *Helicopter information*), was probably explained by the combination of the time between the accident occurring and the witness arriving at the scene, the rupture to the spray tank and the nature of the terrain. This would have allowed any chemical to drain from the tank and down the hill.

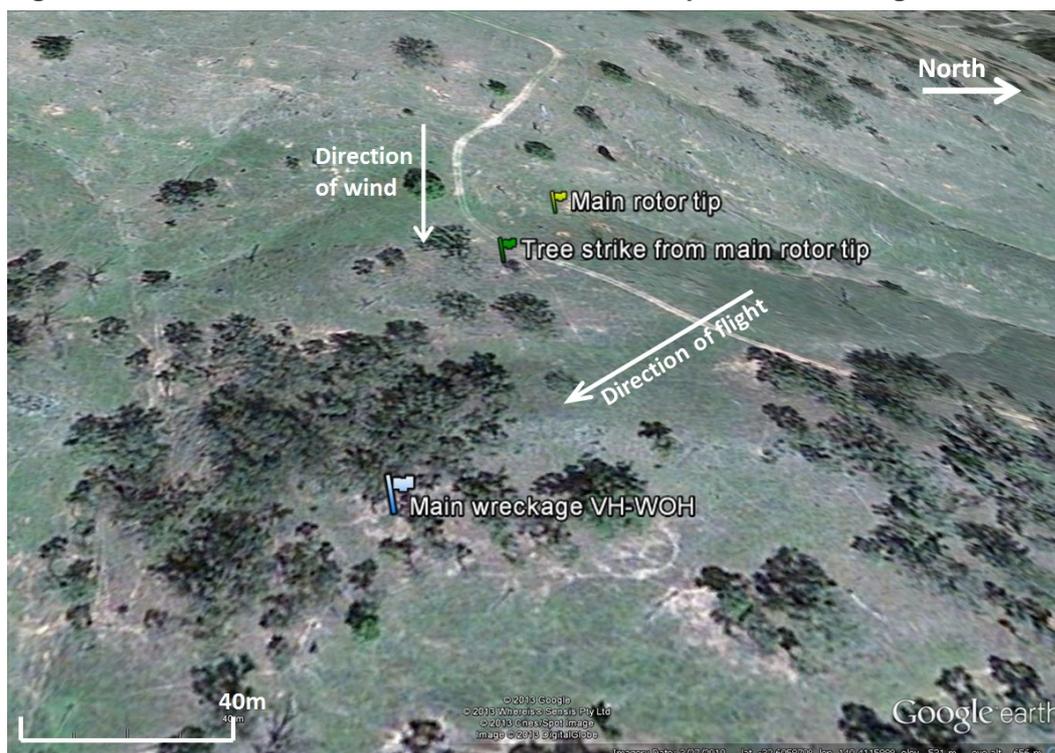
The fuselage and tail, including the tail rotor assembly, and most of the main rotor blades were contained within the impact site. One main rotor blade tip was found about 162 m from the accident site, on the other side of the hill. Damage to a tree in that area was consistent with the main rotor blade tip detaching from near the accident site and travelling up the hill, before striking the tree. The main rotor tip then came to rest on the other side of the hill (Figure 6).

Figure 6: Location of the detached main rotor blade tip and tree damage

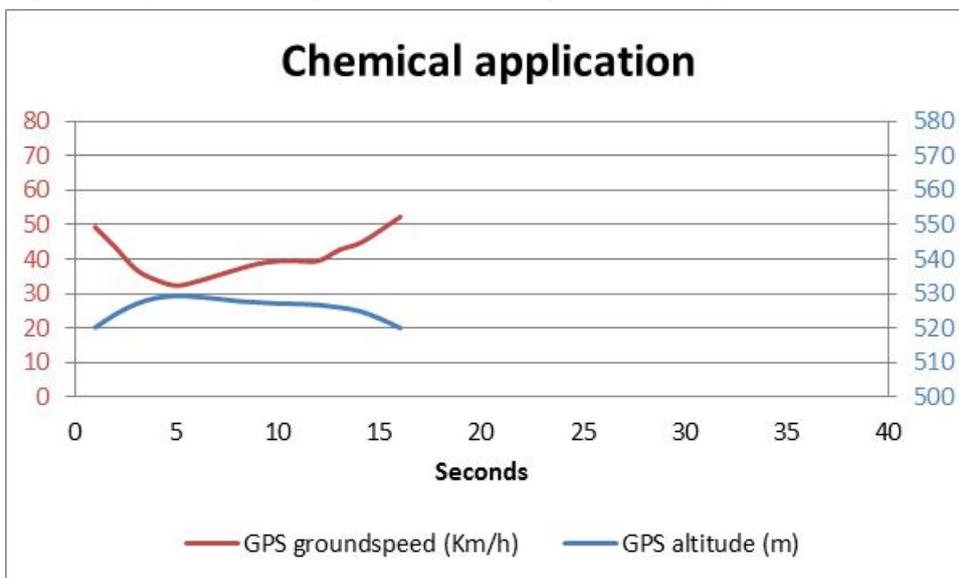
Analysis of the GPS data identified the typical operating profile for the helicopter during aerial spraying activities in the days prior to the accident and the spray runs conducted on the day. These profiles were consistent and showed the pilot operating at speeds as low as 9 kt (17 km/h) in the turns during chemical application. The GPS data also recorded those times when the chemical was dispersed. Examination of this data indicated that on the final spray run the majority of the 240 L of chemical was still on board. The data also showed that while at low speed, the pilot manoeuvred to trade speed for height and vice versa. That is, as the helicopter’s speed dropped off in the turn, it was climbing before, at the top of the climb, the pilot would complete the turn and regain speed (Figure 7). Speed is increased in a helicopter by lowering the nose and applying power as required. Of note, during the accident spray run, the speed did not decrease below effective translational lift (ETL)⁷ until commencement of the final, sustained, climb (Figure 8).

Figure 7: Speed and height variation during chemical application

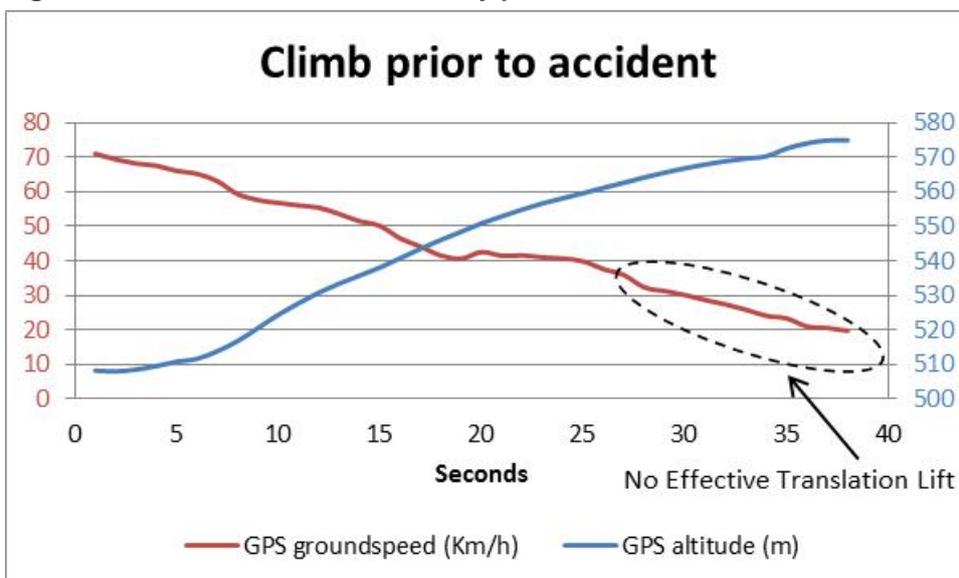
The final segment of GPS data identified that the helicopter was not conducting spray activities at that time. During the final manoeuvring the helicopter climbed for about 35 seconds while the groundspeed reduced to about 10 kt (19 km/h), which, based on the BoM assessment of the likely wind, meant the helicopter’s airspeed was probably at or less than the recorded groundspeed. In this case, the helicopter was no longer above ETL, increasing the engine power required for the manoeuvre. Based on the final groundspeed of about 10 kt (19 km/h), the helicopter would have taken about 6 seconds to cover the 33 m from the last recorded GPS position to the accident site.

Figure 8: Sustained climb immediately prior to the accident

Consideration of the groundspeed and altitude of the final data point with reference to the underlying sloping terrain identified that the helicopter was effectively in an OGE hover at that time.

The GPS analysis further identified that during the climb, the groundspeed of the helicopter decreased to about 10 kt (19 km/h). Given the available performance of the helicopter at its operating weight, as it slowed below effective translational lift (ETL), the power required would have exceeded that available, probably resulting in the main rotor RPM decreasing as the engine was unable to provide the required torque. The resulting overpitch would have led to an unintended descent. The bending, or coning, seen on the main rotor blades was consistent with operation below normal main rotor RPM.
