**ATSB TRANSPORT SAFETY REPORT**  
Aviation Occurrence Investigation  
AO-2009-068  
Final

**Operational event**  
**132 km west of Horn Island Aerodrome**  
**Queensland**  
**9 November 2009**  
**VH-EMZ**  
**Bell Helicopter 412**

Operational event – 132 km west of Horn Island Aerodrome, Queensland – 9 November 2009  
VH-EMZ, Bell Helicopter Company 412

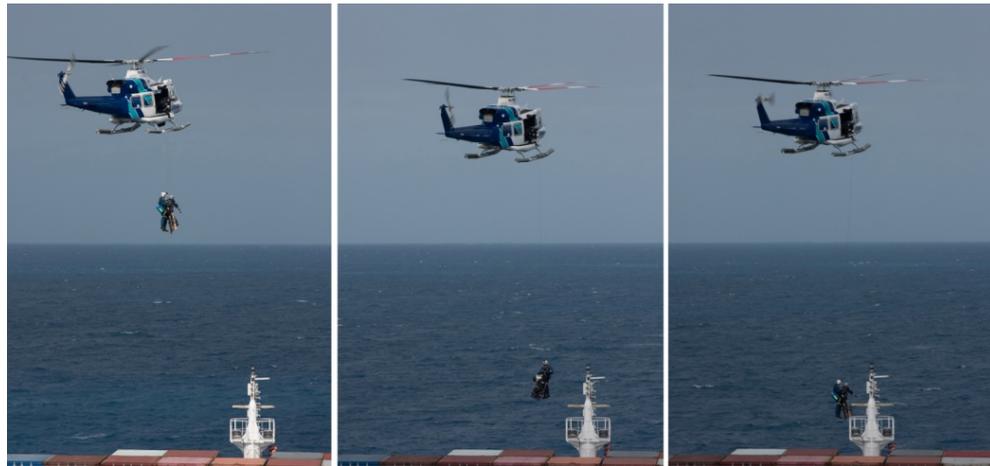
**Figure 6: Approaching the winching area<sup>12</sup>**

The pilot reported that as the helicopter approached overhead the target area with the ship’s structure as a hover reference, he glanced inside the cockpit to check the cockpit instruments. On looking back outside he could no longer see the ship. In response, the pilot changed hover reference to the view of the horizon directly to the front of the helicopter and announced to the ACO that he had ‘lost reference’. The pilot reported that although he had not considered the possibility of losing sight of the ship, he believed that any unintended movement of the helicopter due to the inferior hover reference would be compensated for by guidance from the ACO.

The ACO recalled that at the time the pilot called ‘lost reference’, the RCO and paramedic were about 6 m above the forecastle deck and nearing the centre of the winch area. He stated that on hearing the term ‘lost reference’, he understood that the pilot could no longer see the ship. A short time later, the ACO observed the helicopter begin to drift rearwards towards the ship’s foremast. The ACO immediately announced the drift to the pilot and requested that he move the helicopter forward. In response, the pilot applied a forward correction that he assessed would be sufficient to arrest the movement. However, the helicopter continued to drift towards the foremast.

Shortly after this occurrence, the operator issued a flying staff instruction reemphasising the hazards and risks associated with winching operations. The instruction detailed the importance of adequate power margins and hover reference and that, where practical, they should be assessed over the intended winch area at the intended hover height.

The instruction also stated that where it was expected that the hover reference may be inadequate, the reference was to be assessed overhead the intended winch location prior to lowering personnel below the level of any obstructions or recovering personnel.

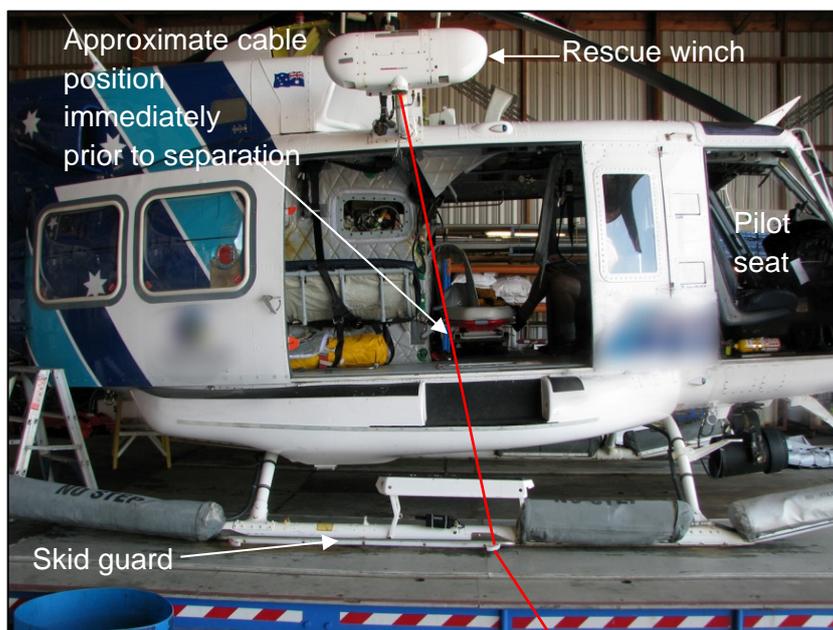
**Figure 7: VH-EMZ**

The helicopter continued to drift backwards over the ship and to the left of the foremast. The ACO observed that the winch cable was caught on the helicopter's skid guard and running at an angle down towards the foremast (Figure 7), and that despite continuing to pay out on the cable, it remained under tension.

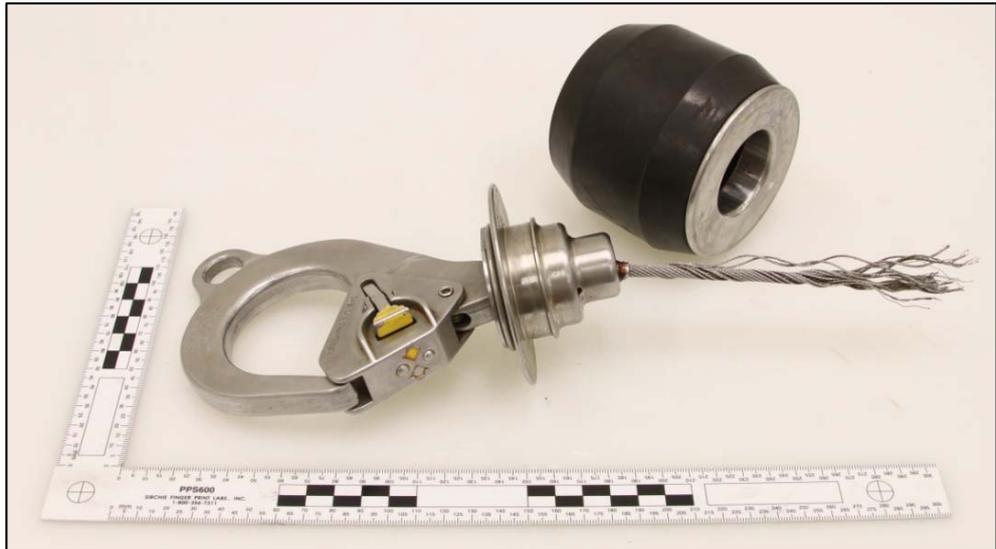
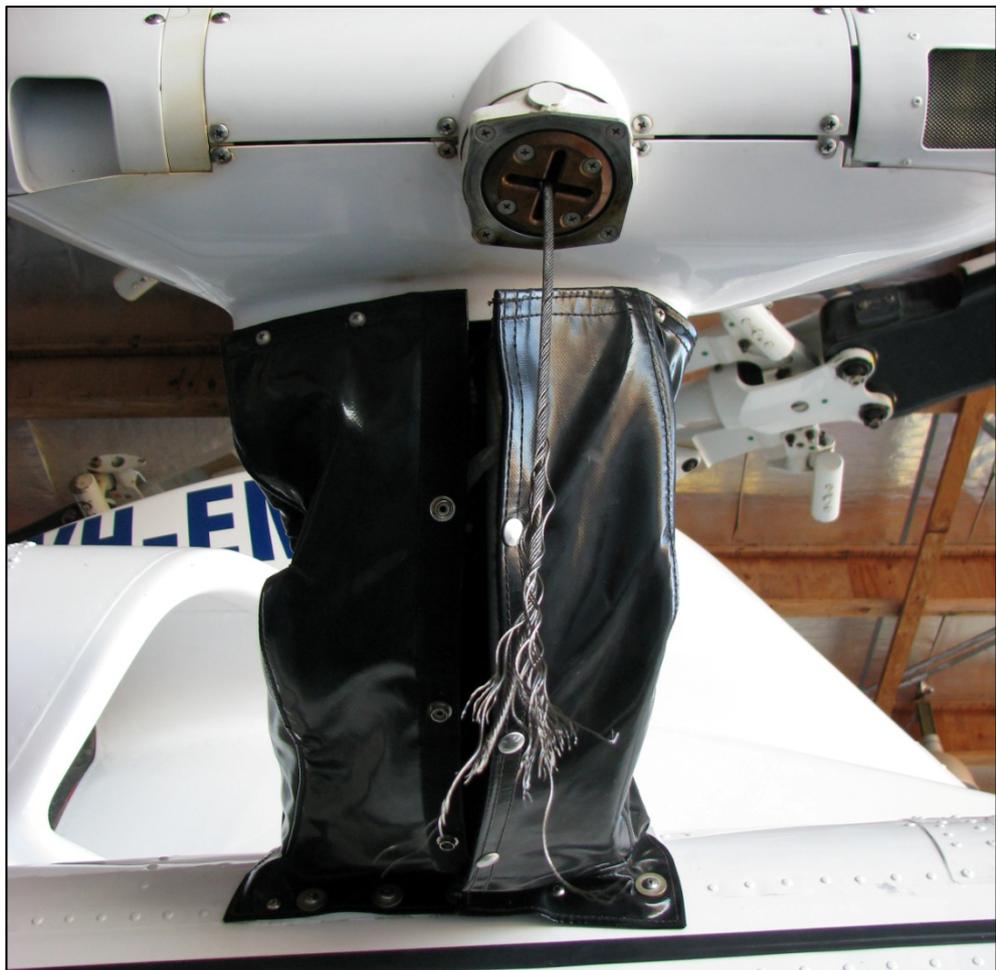
An examination of the helicopter's rescue winch identified that the cable separated about 14 cm from the hook (Figures 9 and 10). There was also evidence of white paint on the bump stop striker plate (Figure 11), which was consistent with contact between the winch cable and the ship's white-coloured foremast structure.

**Figure 9: Winch cable hook and bump stop**

**Figure 10: Winch cable**

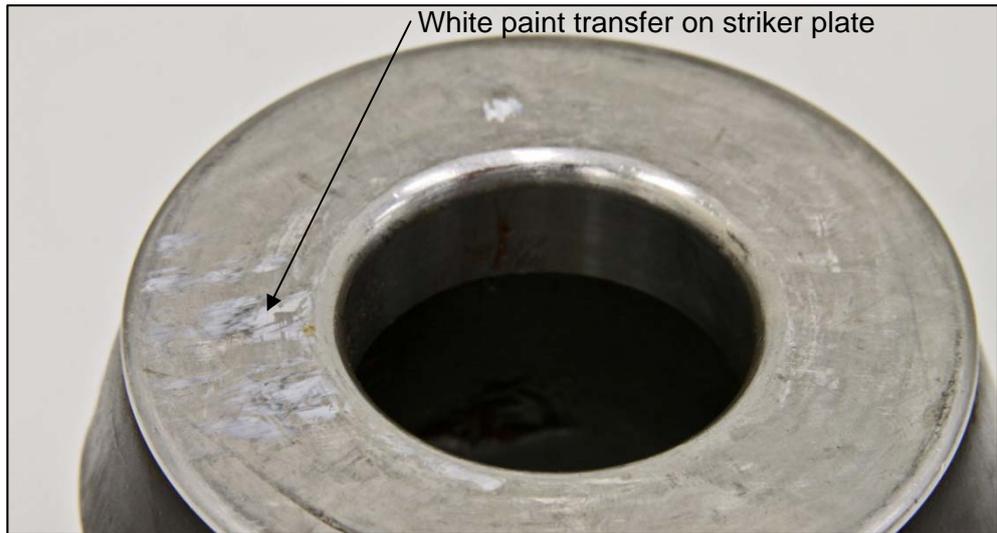
**Figure 11: Contact marks on bump stop striker plate**

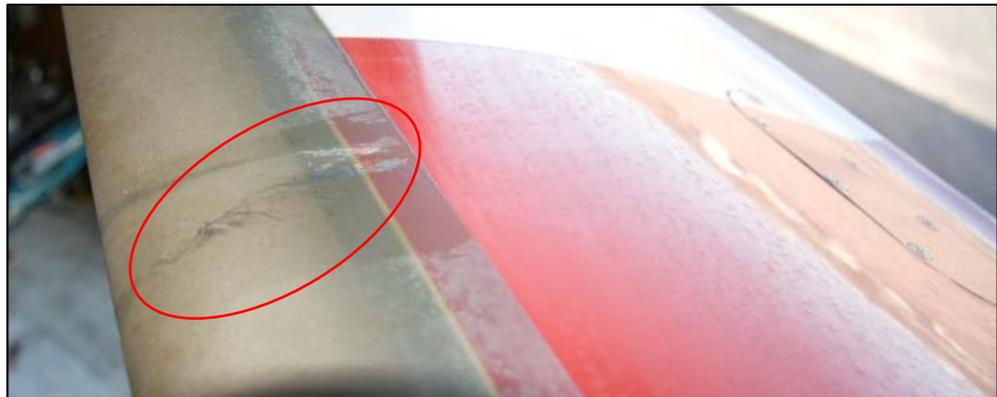
Additionally, marks on the helicopter's main and tail rotor blades, right horizontal stabiliser and cabin roof were consistent with the cable having recoiled following the separation and contacted the helicopter (Figures 12 to 14). The winch and remaining cable, together with the winch hook and cable segment were retained for detailed technical examination.

**Figure 12: Contact marks on the main rotor**

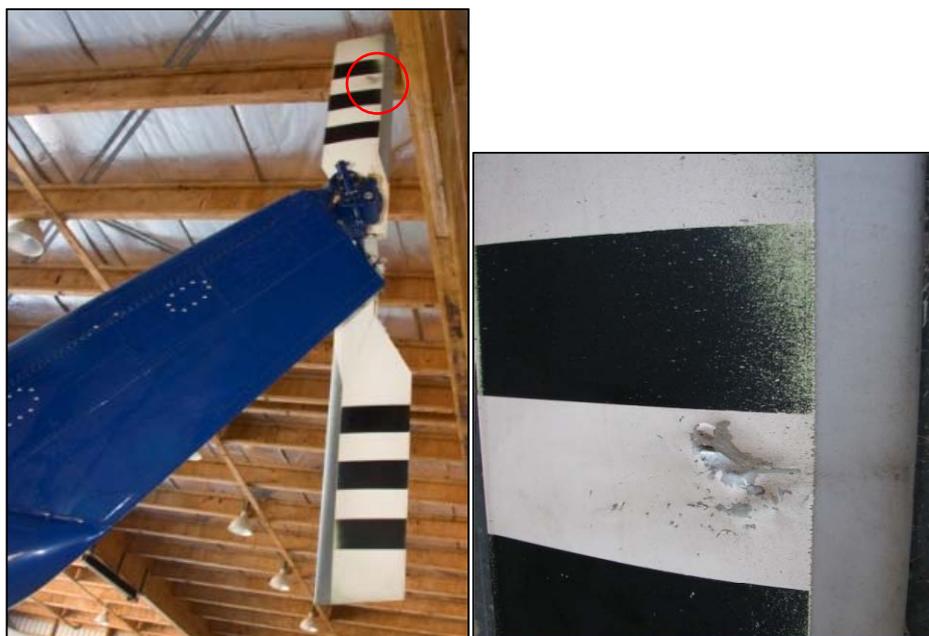
**Figure 13: Contact marks on the tail rotor**

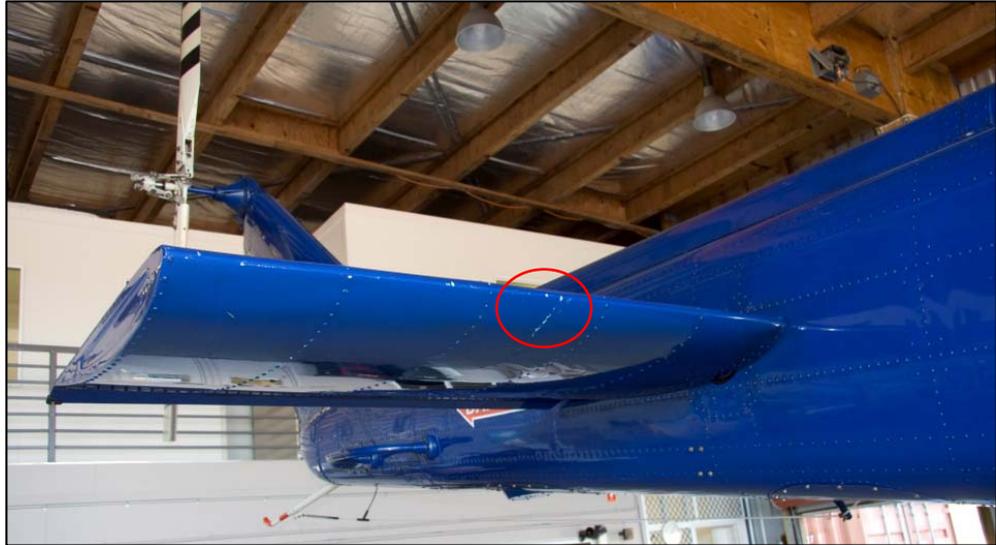
**Figure 14: Contact marks on the horizontal stabiliser**

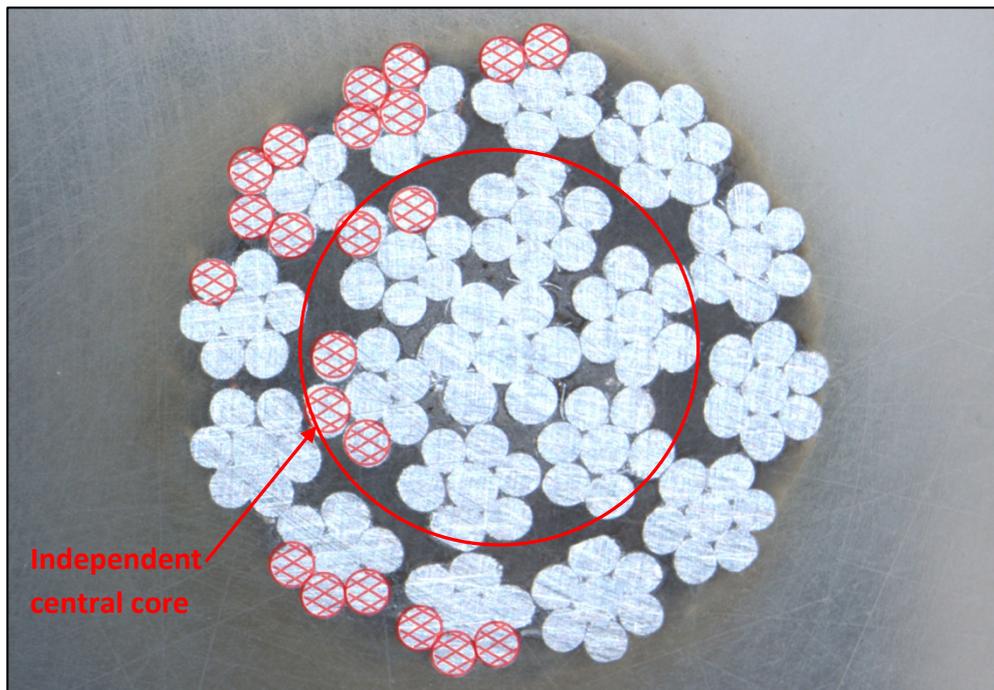
Examination of the winch cable via visual and scanning electron microscopy techniques identified that about 17% of the cable had been severed through abrasive contact with the foremast structure (Figure 16). The separation of the remainder of the cable was consistent with the effects of a combination of shear and tensile overstress. There was no evidence of fatigue failure within any of the cable strands.

**Figure 16: Cross-section of the winch cable - abrasion-damaged strands highlighted in red<sup>14</sup>**

The observed abrasion damage to the cable reduced its cross sectional area by about 17%, which produced a corresponding reduction in the load-carrying capacity of the winch cable. Additionally, contact marks evident on the ship's radar scanner and associated railing indicated that at some point during the accident sequence, the cable became bent over the edges of this structure, further reducing the strength of the cable.

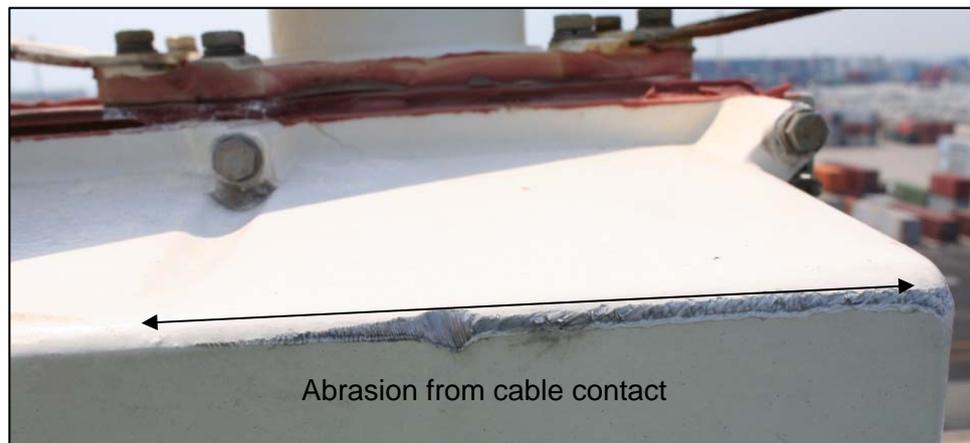
An examination of the foremast structure following the ship's arrival in Brisbane identified marks that were consistent with contact between the winch cable and the radar scanner and the associated platform railing (Figures 17 to 20).

**Figure 17: Contact marks on the radar scanner**

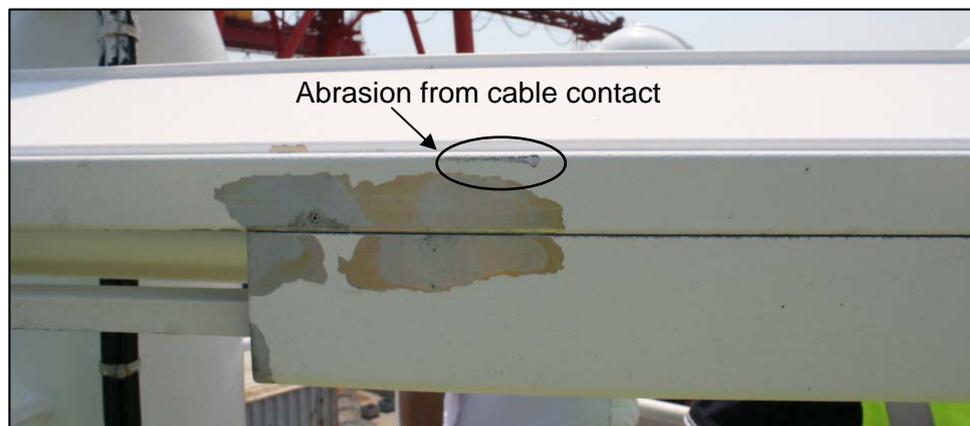
**Figure 18: Additional contact marks on the radar scanner**

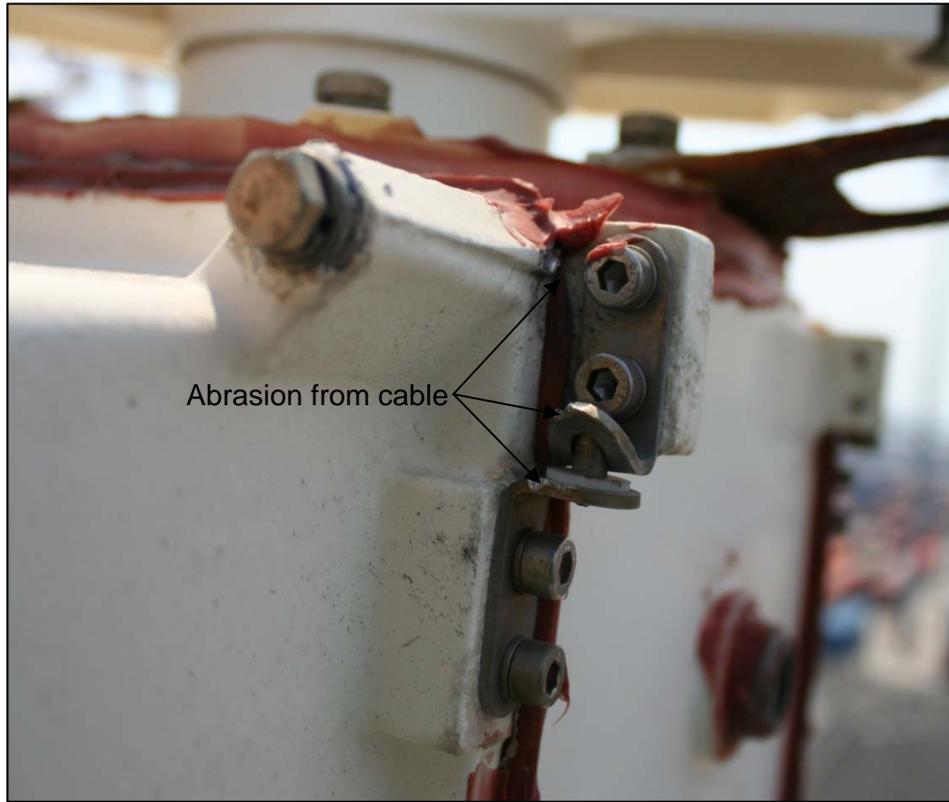
**Figure 19: Additional contact marks on the radar scanner**

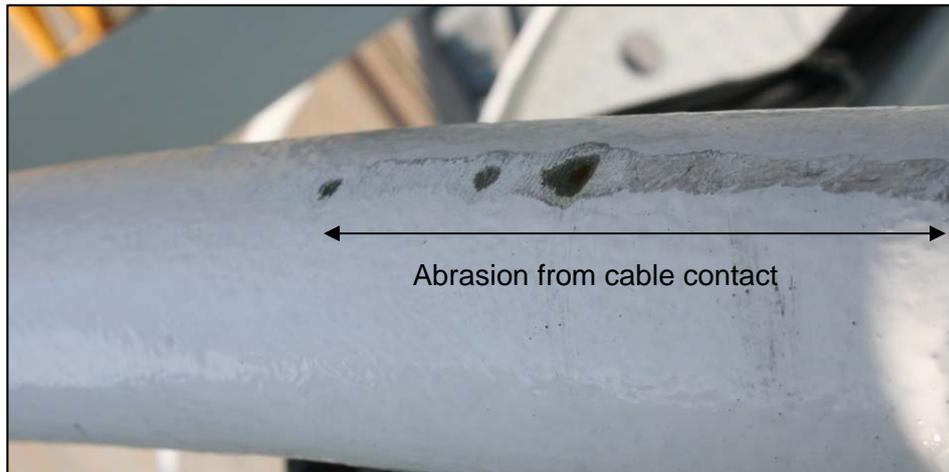
**Figure 20: Contact marks on the radar scanner platform railing**
