Australian Transport Safety Bureau

AO-2013-136

Preliminary – 10 October 2013

The occurrence

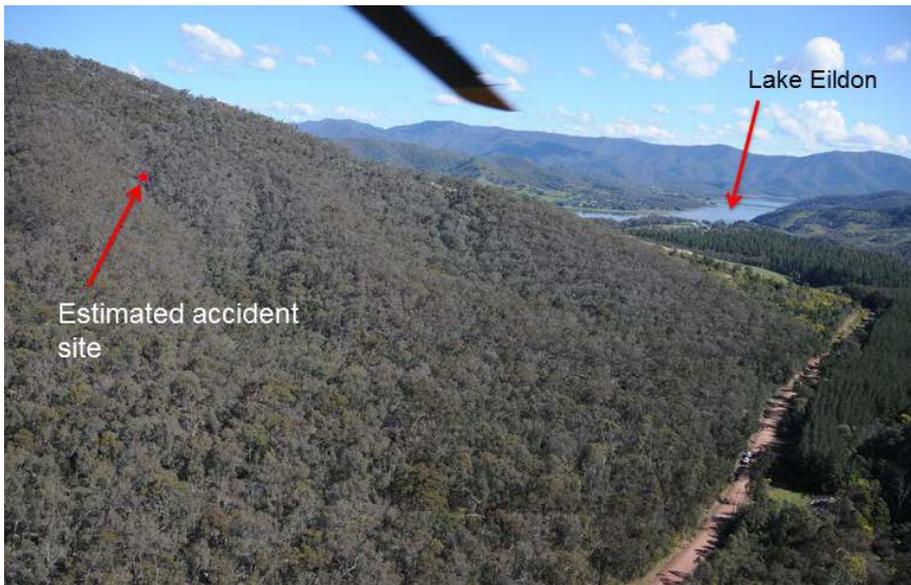
Figure 2: Accident scene looking south-west

At about 1145 the helicopter arrived overhead the ground party and patient who were located in a heavily-wooded area in steep terrain about 1-1.5 km from the nearest road (Figure 2). The trees in the surrounding area were up to 60 ft high and the crew noted numerous dead branches that could create a hazard for winching operations.

Despite the crew's efforts, the patient slipped out of the strop and fell to the ground, sustaining fatal injuries.

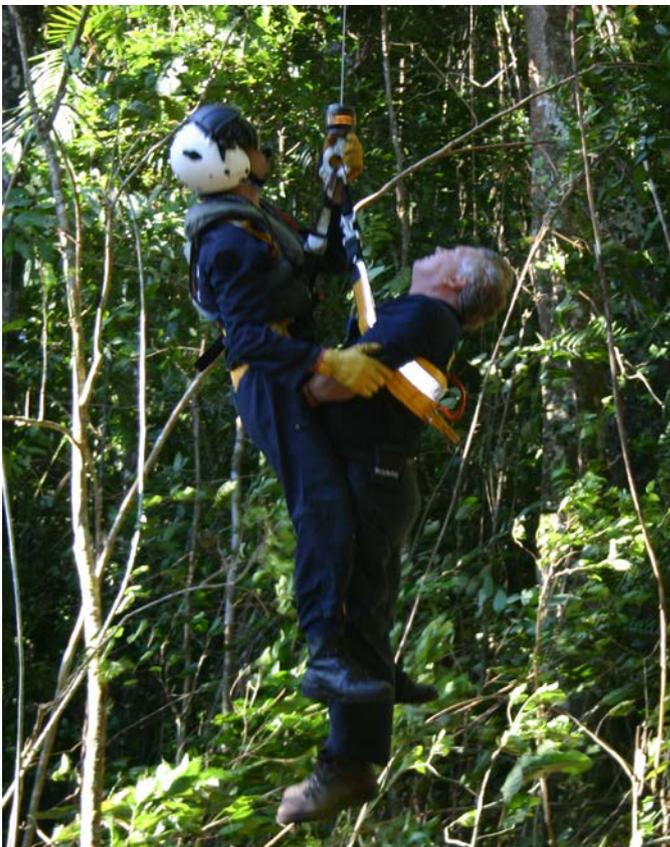
Figure 3: Example of a double-lift with rescue/retrieval strop

The crew located a suitable area into which to winch the paramedic to assess the patient's condition. They discussed likely retrieval options and decided that a stretcher winch would be too dangerous due to the steep terrain, surrounding vegetation and the possibility of fouling. Due to the small winch area and the possible fouling hazard, the crew elected for a double-lift extraction with the patient in a rescue/retrieval strop (strop) (Figure 3).

The aircrewman reported that once the paramedic and patient were clear of the canopy, at about 15 ft below the aircraft, he noticed that the patient was moving or wriggling. The aircrewman stopped the winch for a control check, and shortly after resuming the winch noticed that the patient's arms were not in the usual position in the strop and that the paramedic appeared to be shouting at the patient. The aircrewman elected to continue winching in, and informed the pilot that the patient was slipping.

As the paramedic and patient reached the height of the helicopter's right skid-landing gear, the paramedic was facing the helicopter and the patient was facing outwards. The paramedic reported attempting to pin the patient against the skid in an attempt to stop him slipping. The aircrewman continued winching until the paramedic's head was level with the middle of the door opening. At this stage the aircrewman informed the pilot that he could see the patient slipping further. He dropped the winch pendant and reached down, grabbing the patient's shoulder in an attempt to stop his fall. The aircrewman stated that by this stage the patient appeared to be unresponsive and limp.

An interim report has been published by the operator with associated safety action. This included reinforcing the need to critically assess a patient's physical and medical state and any associated risks before committing to using the rescue/retrieval strop. An order of priority use of rescue equipment was promulgated for application in overland winch operations.

The ATSB advises helicopter emergency medical service and other operators carrying out winching operations to note the circumstances of this accident and consider the implications for their operations of the risk of patients or other persons being winched to slip out of a rescue/retrieval strop. In this context the size, weight and medical condition of the person(s) being winched may indicate that other recovery options offer reduced risk.
