23 April 2015

Our ref: GENZTAUC13086AF-AH

**Re: Palisade Retaining Wall and Staircase Certification, The Lakes Subdivision Stage 3**

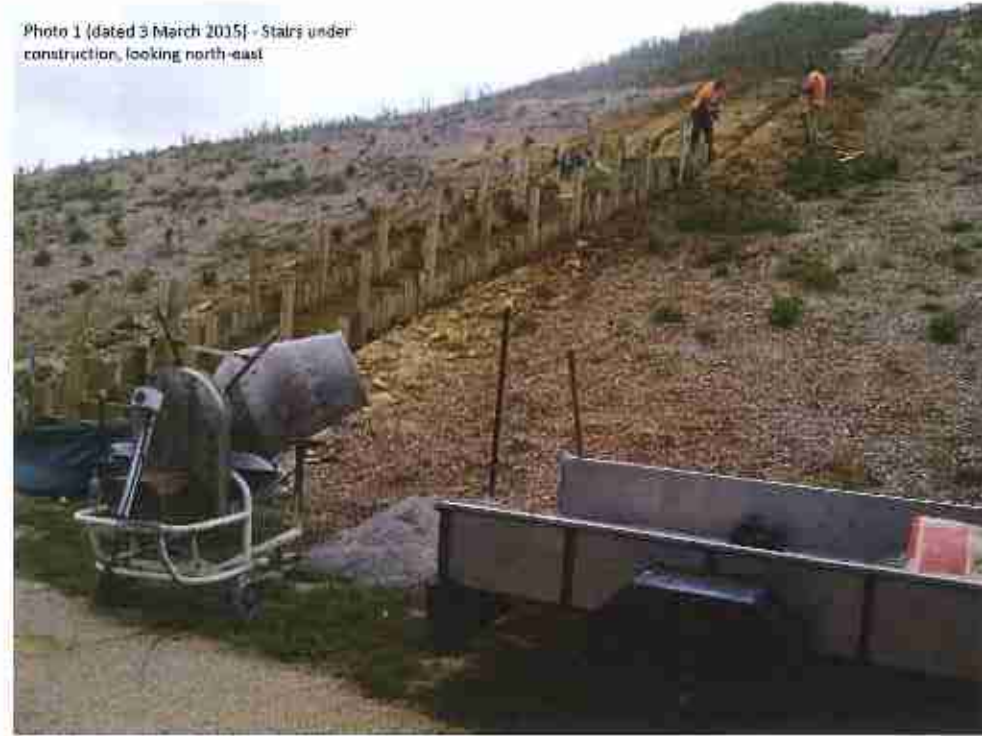
Subsequent, approximately weekly inspections were carried out during construction. Photo 1 (attached) was taken on the 3<sup>rd</sup> of March 2015 and shows the vertical posts and horizontal rails supporting each step installed over approximately 25% of the alignment. Photos 2 and 3 show the completed staircase on 10<sup>th</sup> of April 2015. In photo 3 the horizontal timber rails supporting each third step can be seen extending through the vertical side of the staircase and being supported on the adjacent vertical post per recommendation 3 above.

Photo 1 (dated 3 March 2015) - Stairs under construction, looking north-east

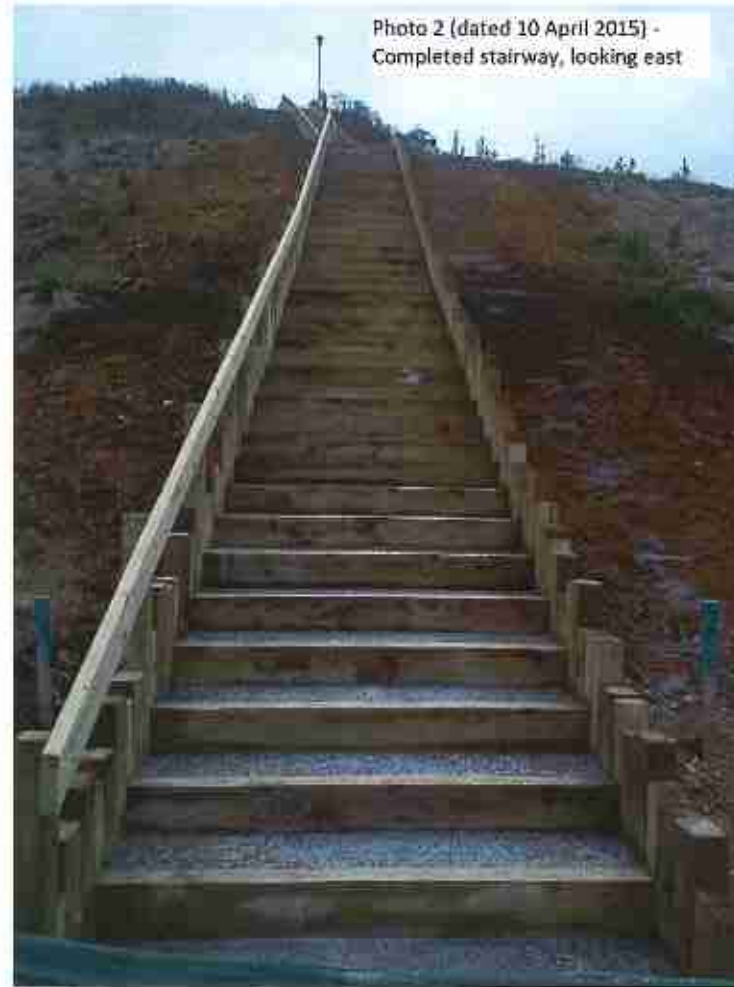
Photo 2 (dated 10 April 2015) - Completed stairway, looking east

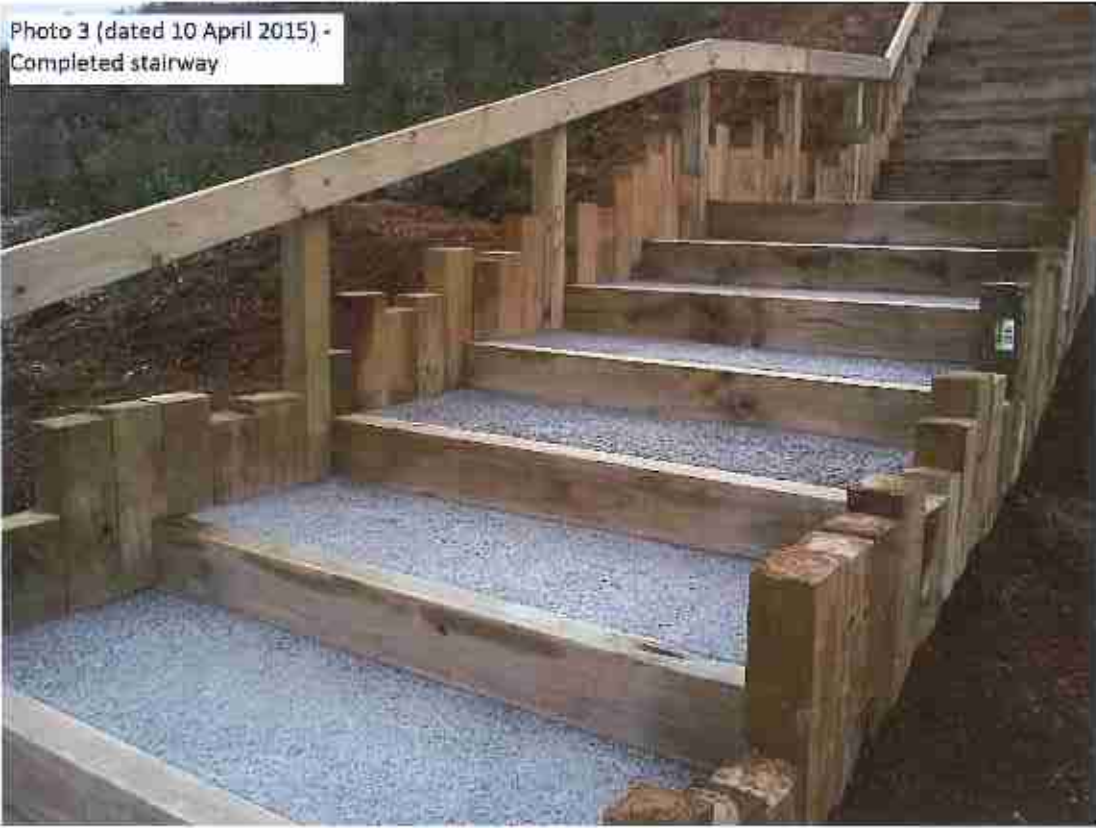
Photo 3 (dated 10 April 2015) -  
Completed stairway

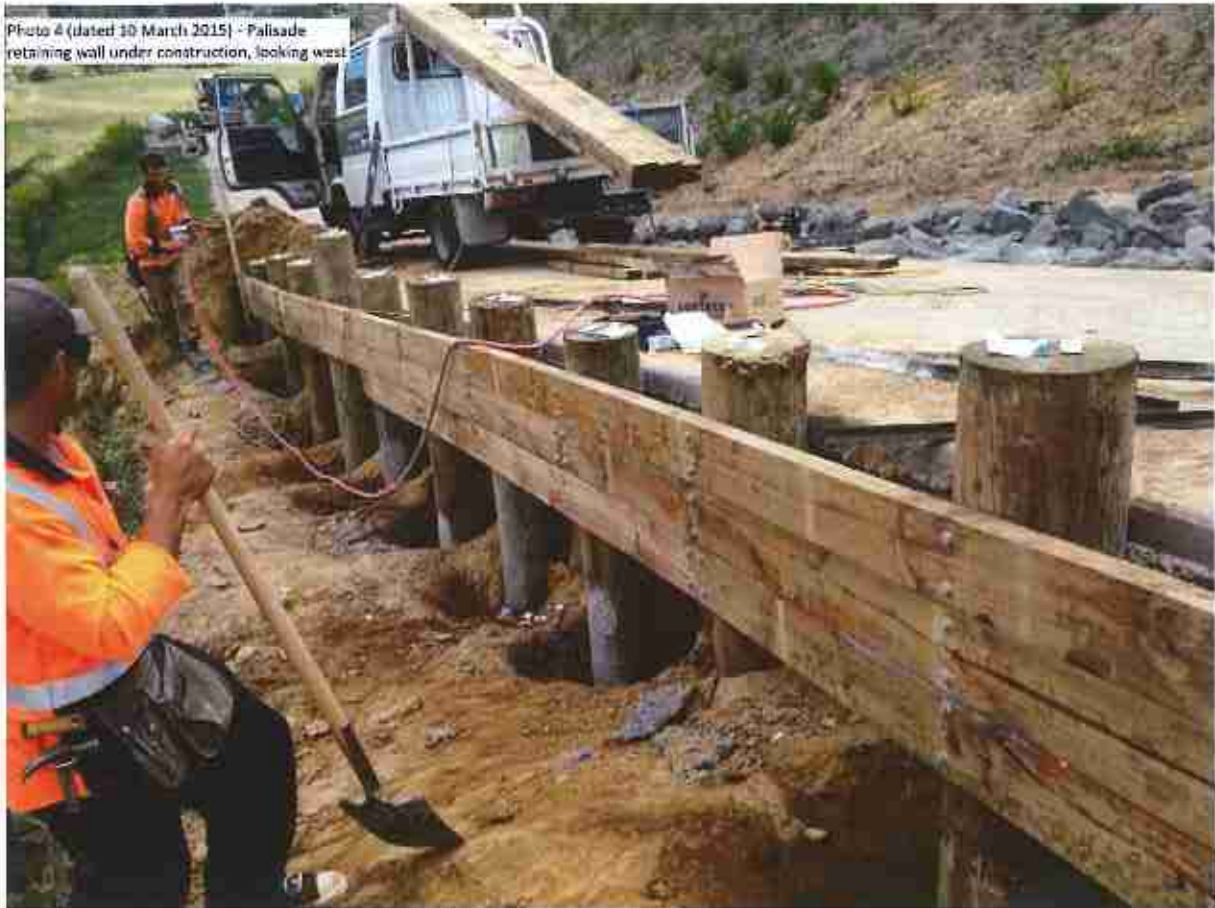
Following the first inspection, Coffey inspected the site on an approximately weekly basis during construction. Photos 4, 5 and 6 show the partially constructed wall on the 10<sup>th</sup> of March 2015. The posts have been installed and the first timber rails are being fitted. Measurements at this time indicated the posts were of the correct dimensions. As shown in this photo the post holes had not been filled with concrete to the base of the rails as shown on the design drawings. The contractor was instructed to completely fill the holes with concrete after the last (bottom) rail had been fitted. Subsequent inspections indicated this was done.

Photo 4 (dated 10 March 2015) - Palisade retaining wall under construction, looking west

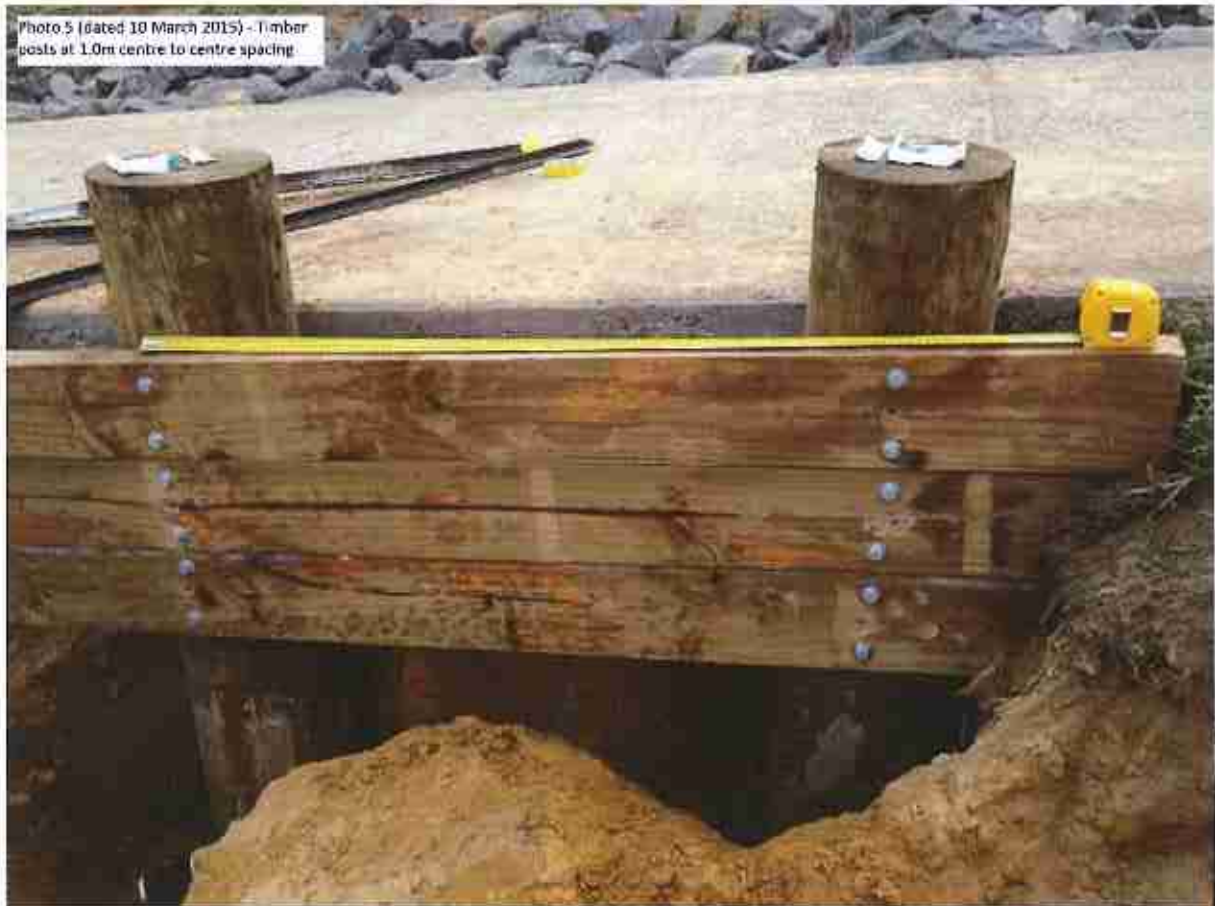
Photo 5 (dated 10 March 2015) - Timber posts at 1.0m centre to centre spacing

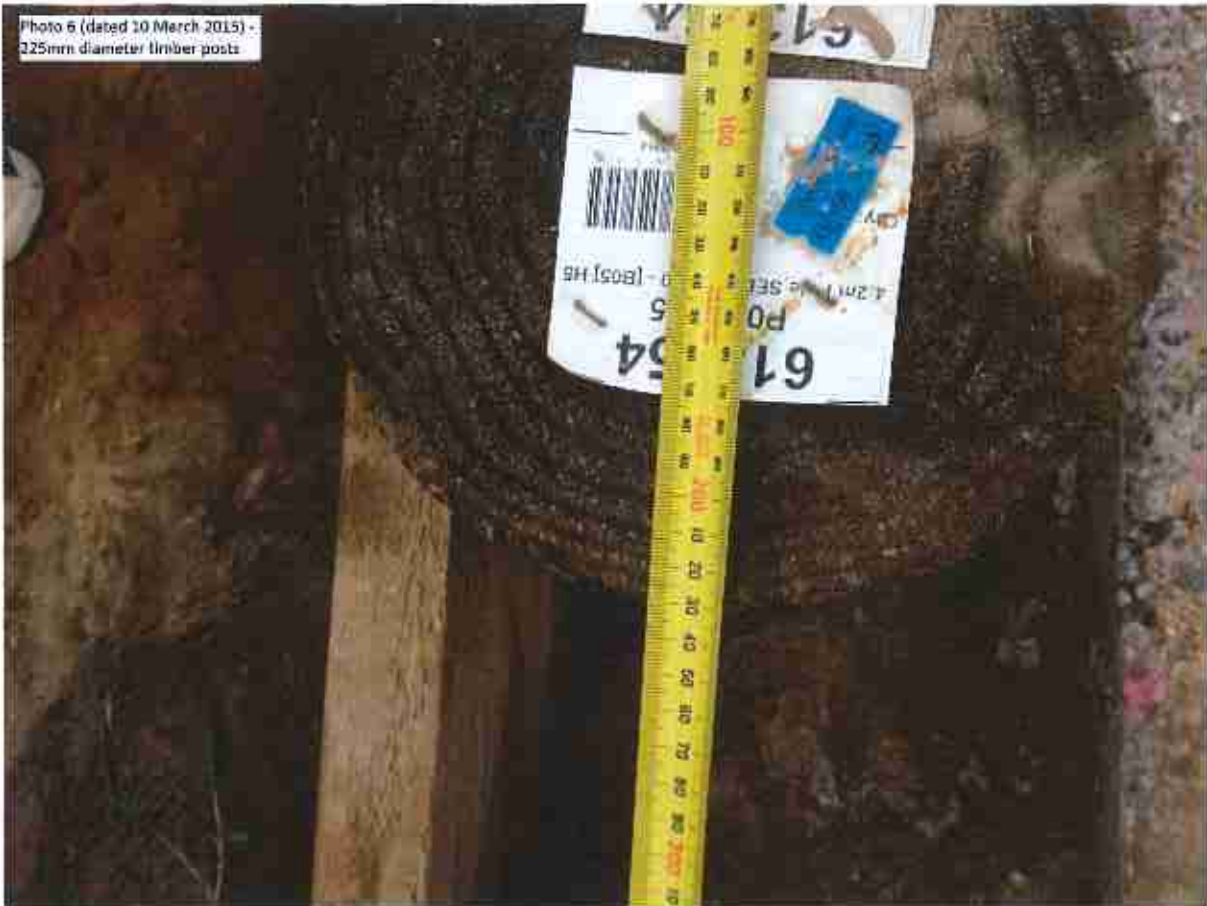
Photo 6 (dated 10 March 2015) -  
225mm diameter timber posts

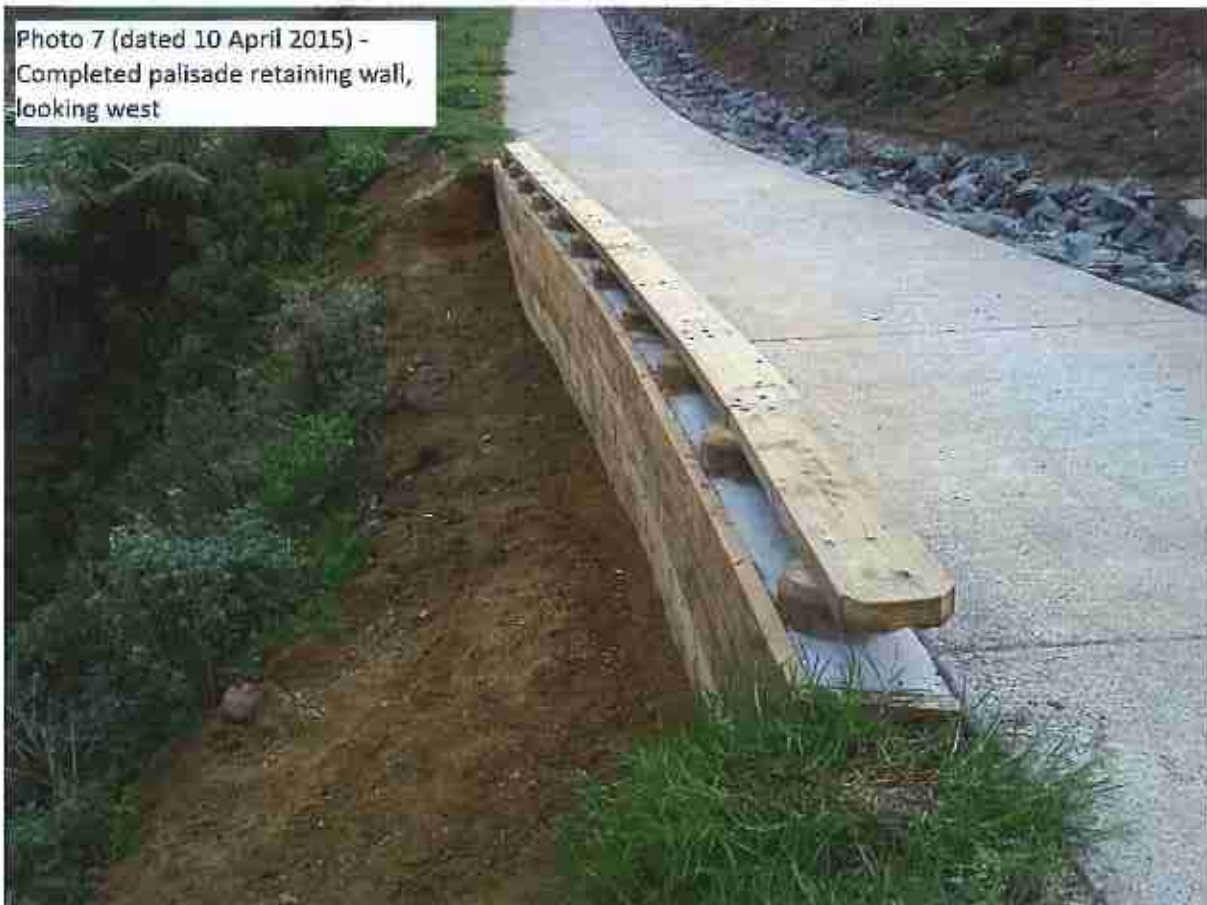
Photos 7 and 8 show the completed wall. The timber rails have been fitted as recommended and the top of the wall has been 'capped' with concrete to prevent stormwater infiltrating behind the wall. The timber kick rail has also been fitted.

To avoid the need for a fall protection barrier, Coffey's design report recommended that once the wall was finished, well compacted soil or topsoil be placed against the exposed face to reduce the exposed height of the wall to less than 1.0m. This work had not been done at the time of the attached photos but has since been completed and inspected by Coffey.

Photo 7 (dated 10 April 2015) -  
Completed palisade retaining wall,  
looking west

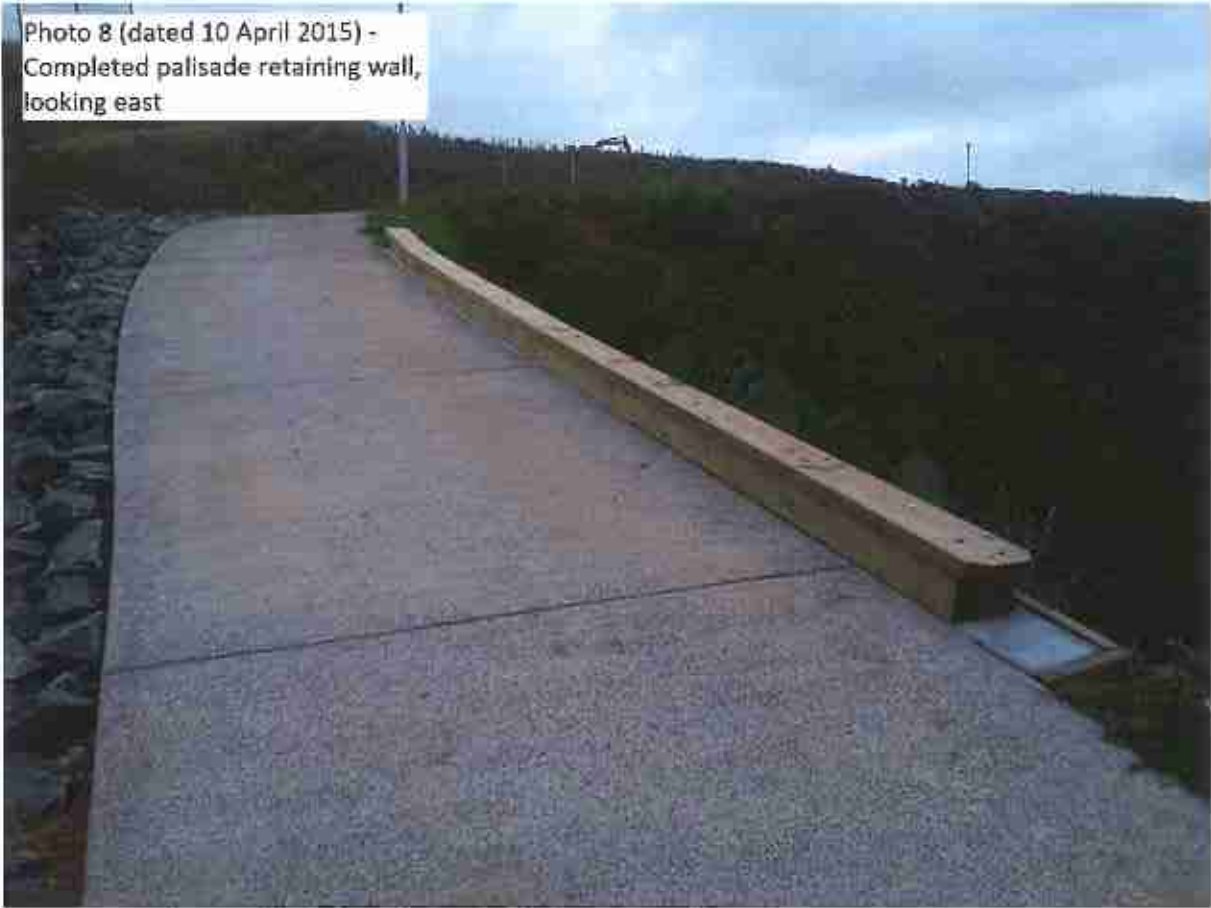
Photo 8 (dated 10 April 2015) -  
Completed palisade retaining wall,  
looking east
