The Lakes Subdivision - Stage 3A & 3B

Geotechnical Completion Report

24 April 2015

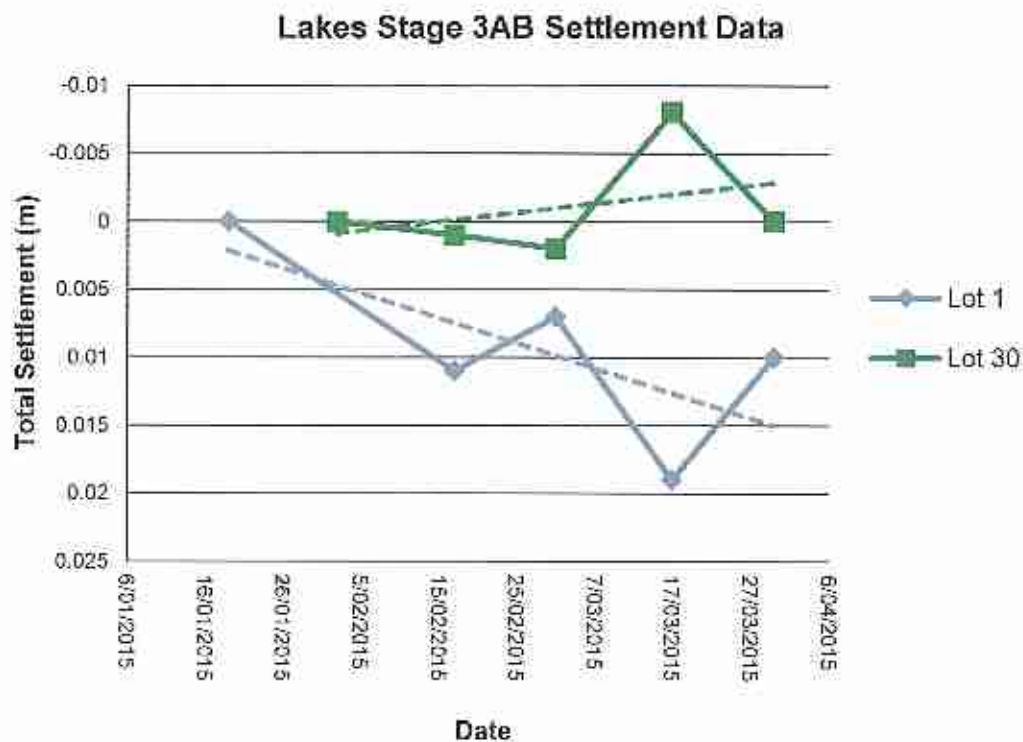
As noted in Section 6.2.3, settlement markers were installed by Higgins on Lot 1 and Lot 30 during the civil works season in 2014 – 2015 and after approximately 2.0m and 1.4m of fill was placed on these sites respectively. The marker locations are shown on Figure 6. Plots of the data from these points provided by HGCL are graphed below. It is noted that the settlement data appear to be affected by significant fluctuation and the survey methodology used can cause such fluctuation. Future monitoring of the settlement marker on Lot 1 will be completed by HGCL using a more accurate levelling instrument to reduce these errors.

The data suggest that Lot 1 has settled approximately 10mm to 20mm at the time of writing (allowing for survey tolerances) and that settlement is likely to be continuing at this location. It is therefore recommended that construction on Lot 1 and Lot 2 should not proceed until further monitoring and analyses by a TCC Category 1 geotechnical professional confirm that settlement has reached an acceptable level for the proposed development.

The data for Lot 30 indicates that limited settlement has occurred at this location since the settlement marker was installed towards the end of the 2015 earthworks season (within survey tolerances). It is therefore considered that Lot 30 and the adjacent lots which received minor filling in 2015 are adequate for residential development subject to the other recommendations in this report.

It is noted that Lots 1 and 2 are currently subject to on-going settlement monitoring. As stated in Section 8.3, development should not proceed on these lots until this settlement has been reviewed and approved by a Category 1 geotechnical professional.
