Gearbox component failure to blame for latest EC225 ditching

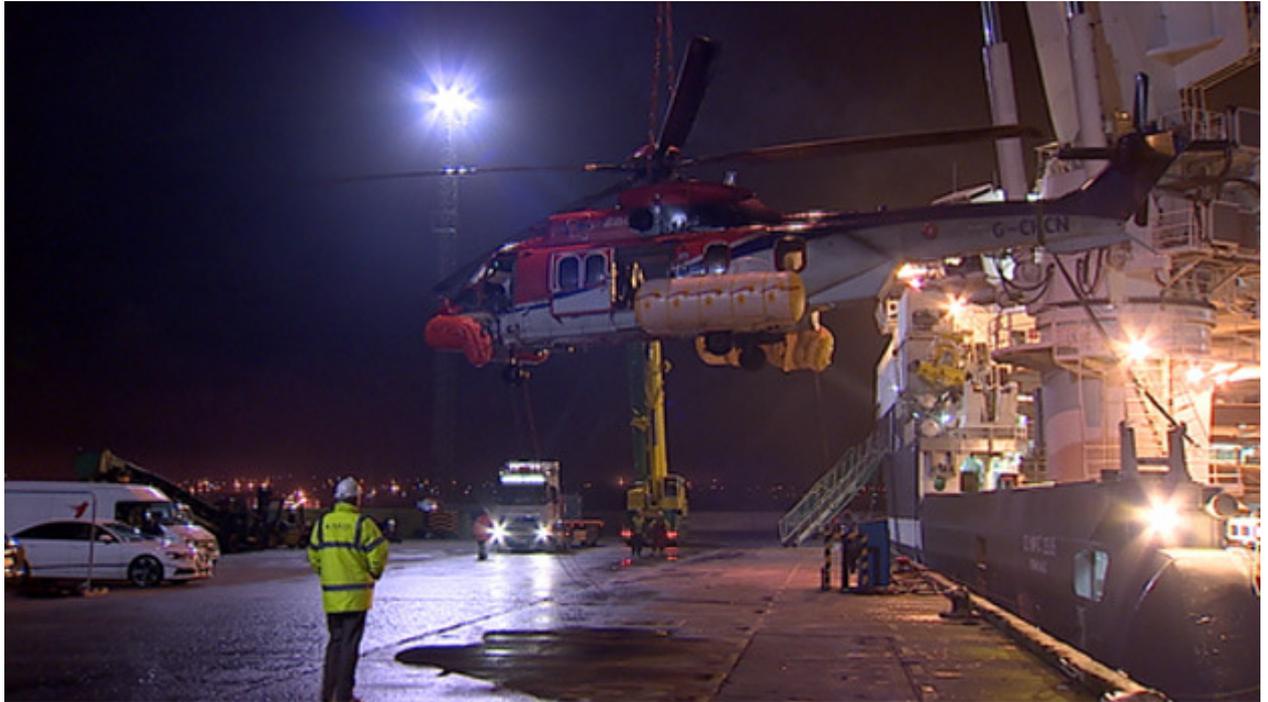
Initial investigations into the 22 October ditching in the North Sea of a Eurocopter EC225 Super Puma show strong similarities to an earlier controlled ditching involving the same aircraft type in May this year, with the failure of a critical gearbox component again the trigger for the incident.

A preliminary examination of the main gearbox on G-CHCN, showed, as with G-REDW, a 360° circumferential crack on the bevel gear vertical shaft, says the AAIB. This meant the gears that operate the main oil pump were no longer being driven.
