**The Lakes - Stages 3G, 3H & Lots 236-239 (Stage D)**

**Geotechnical Completion Report**

17 February 2017

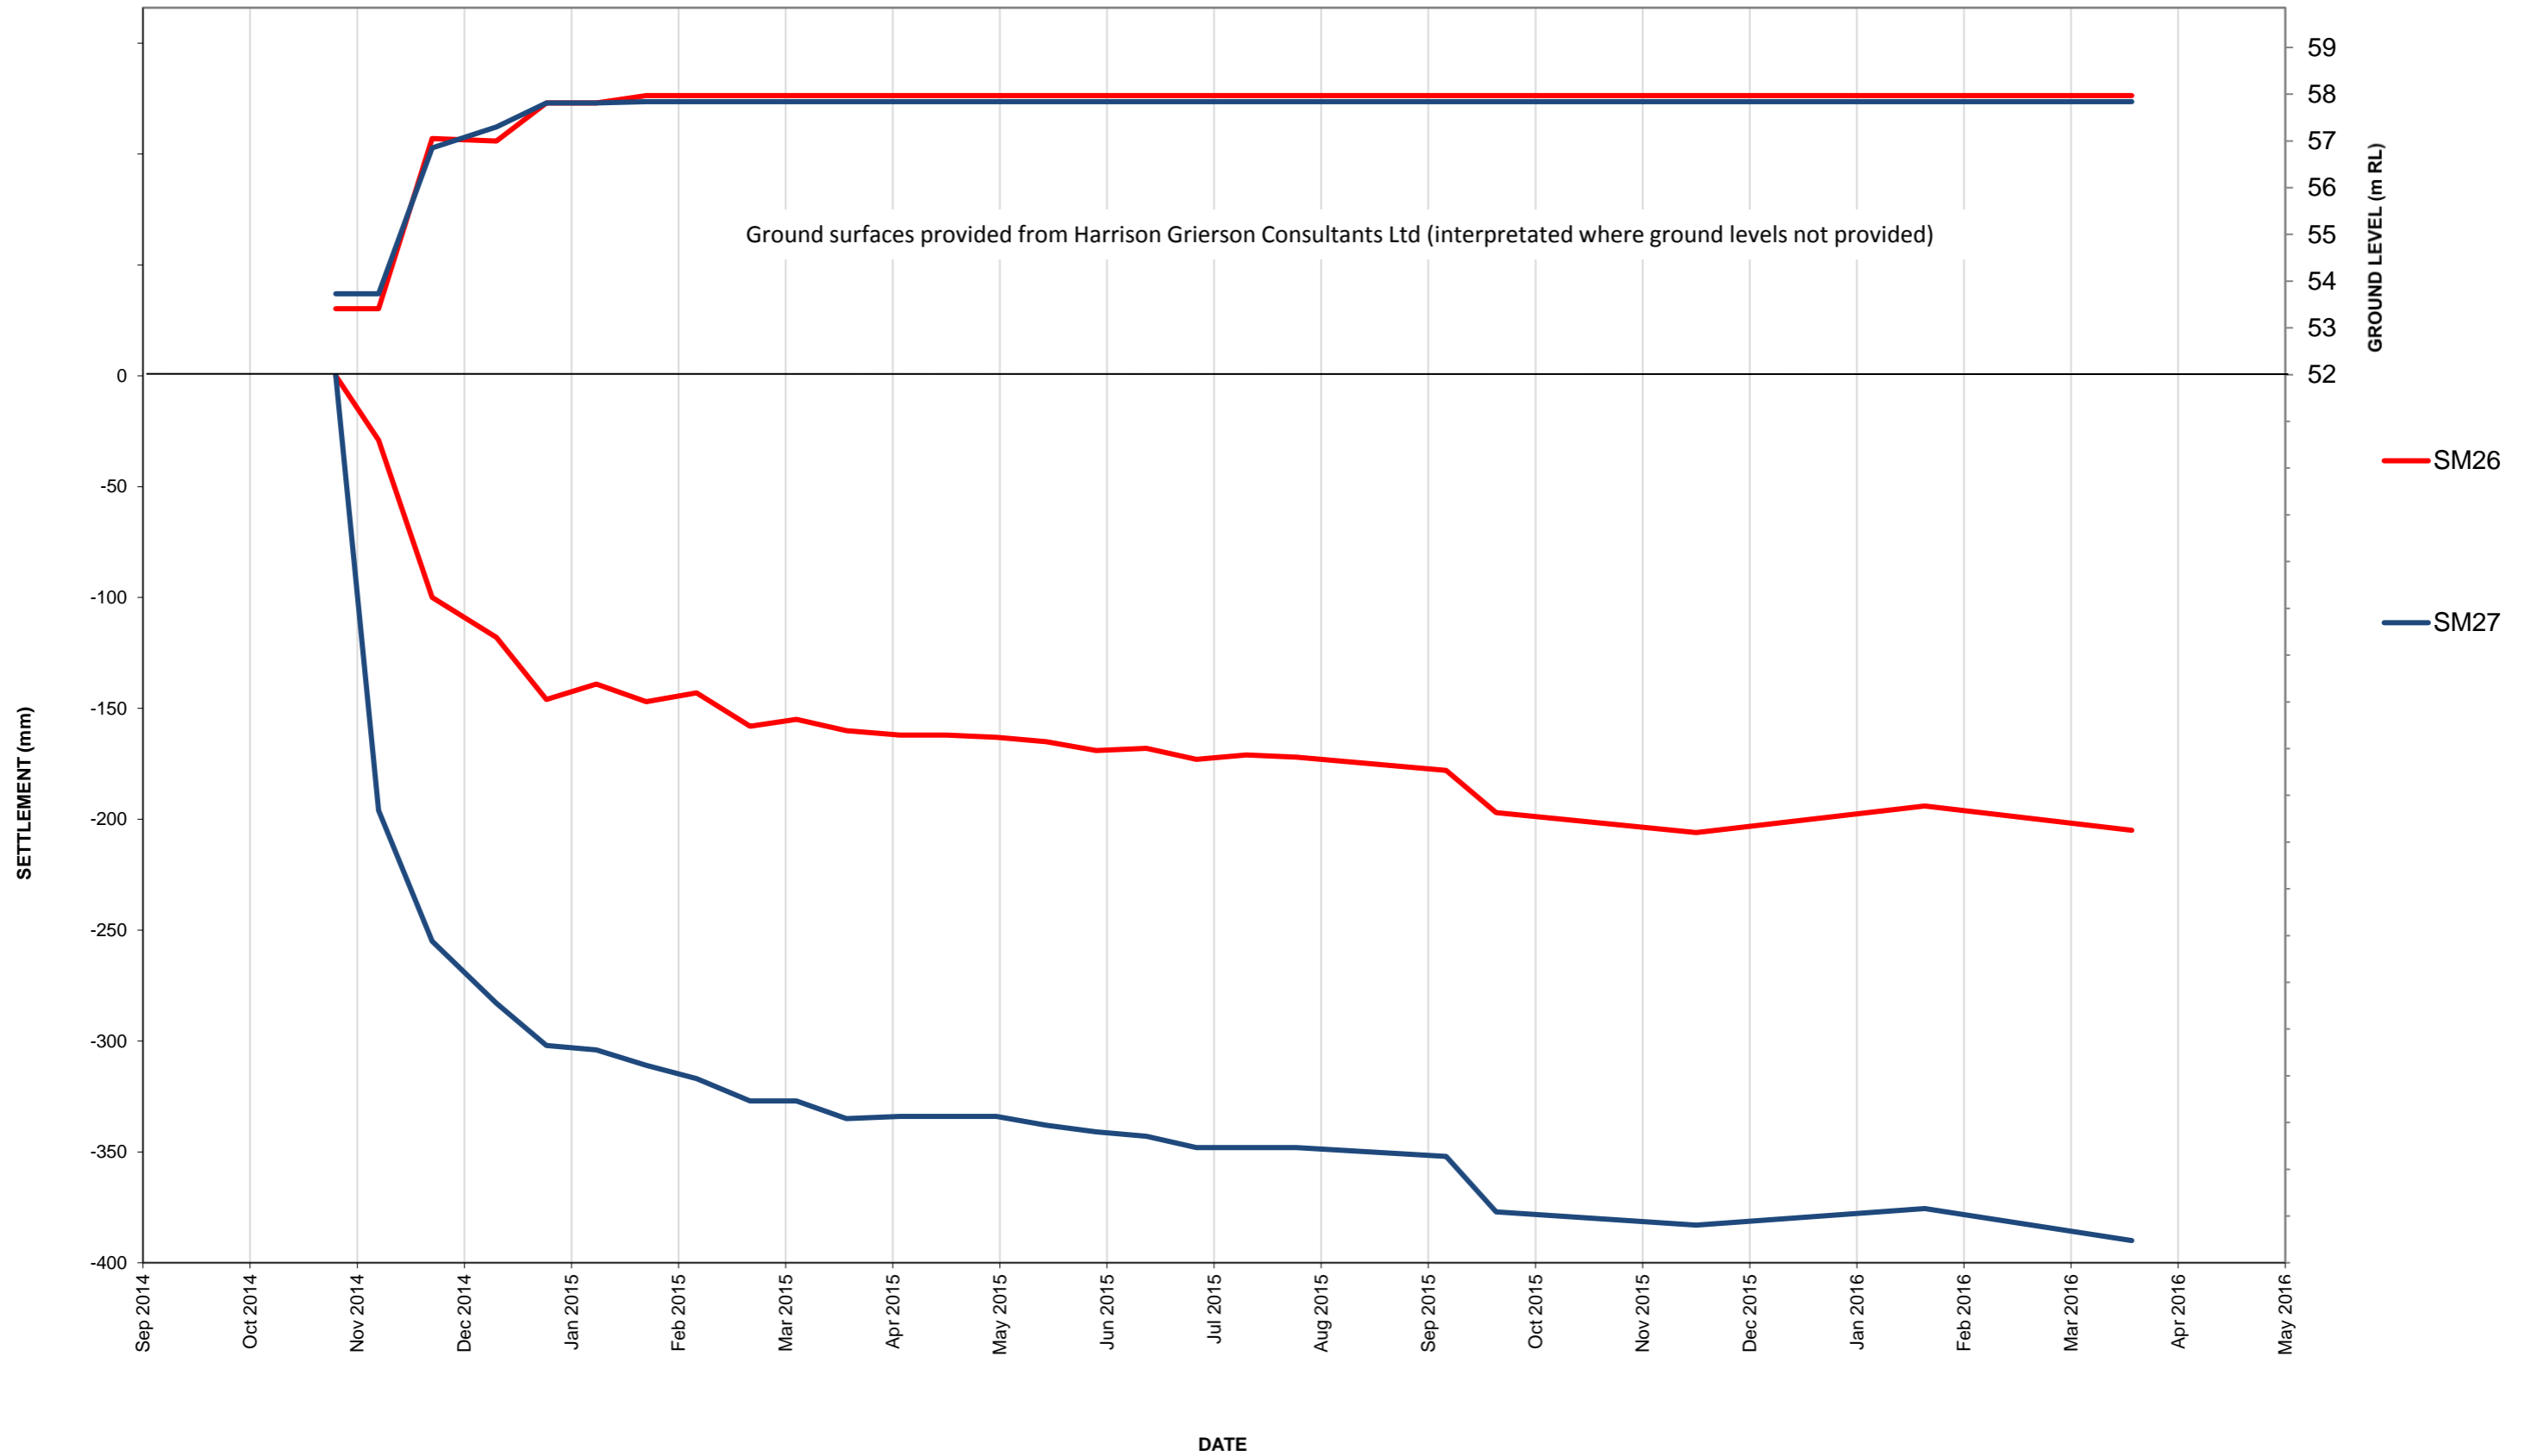
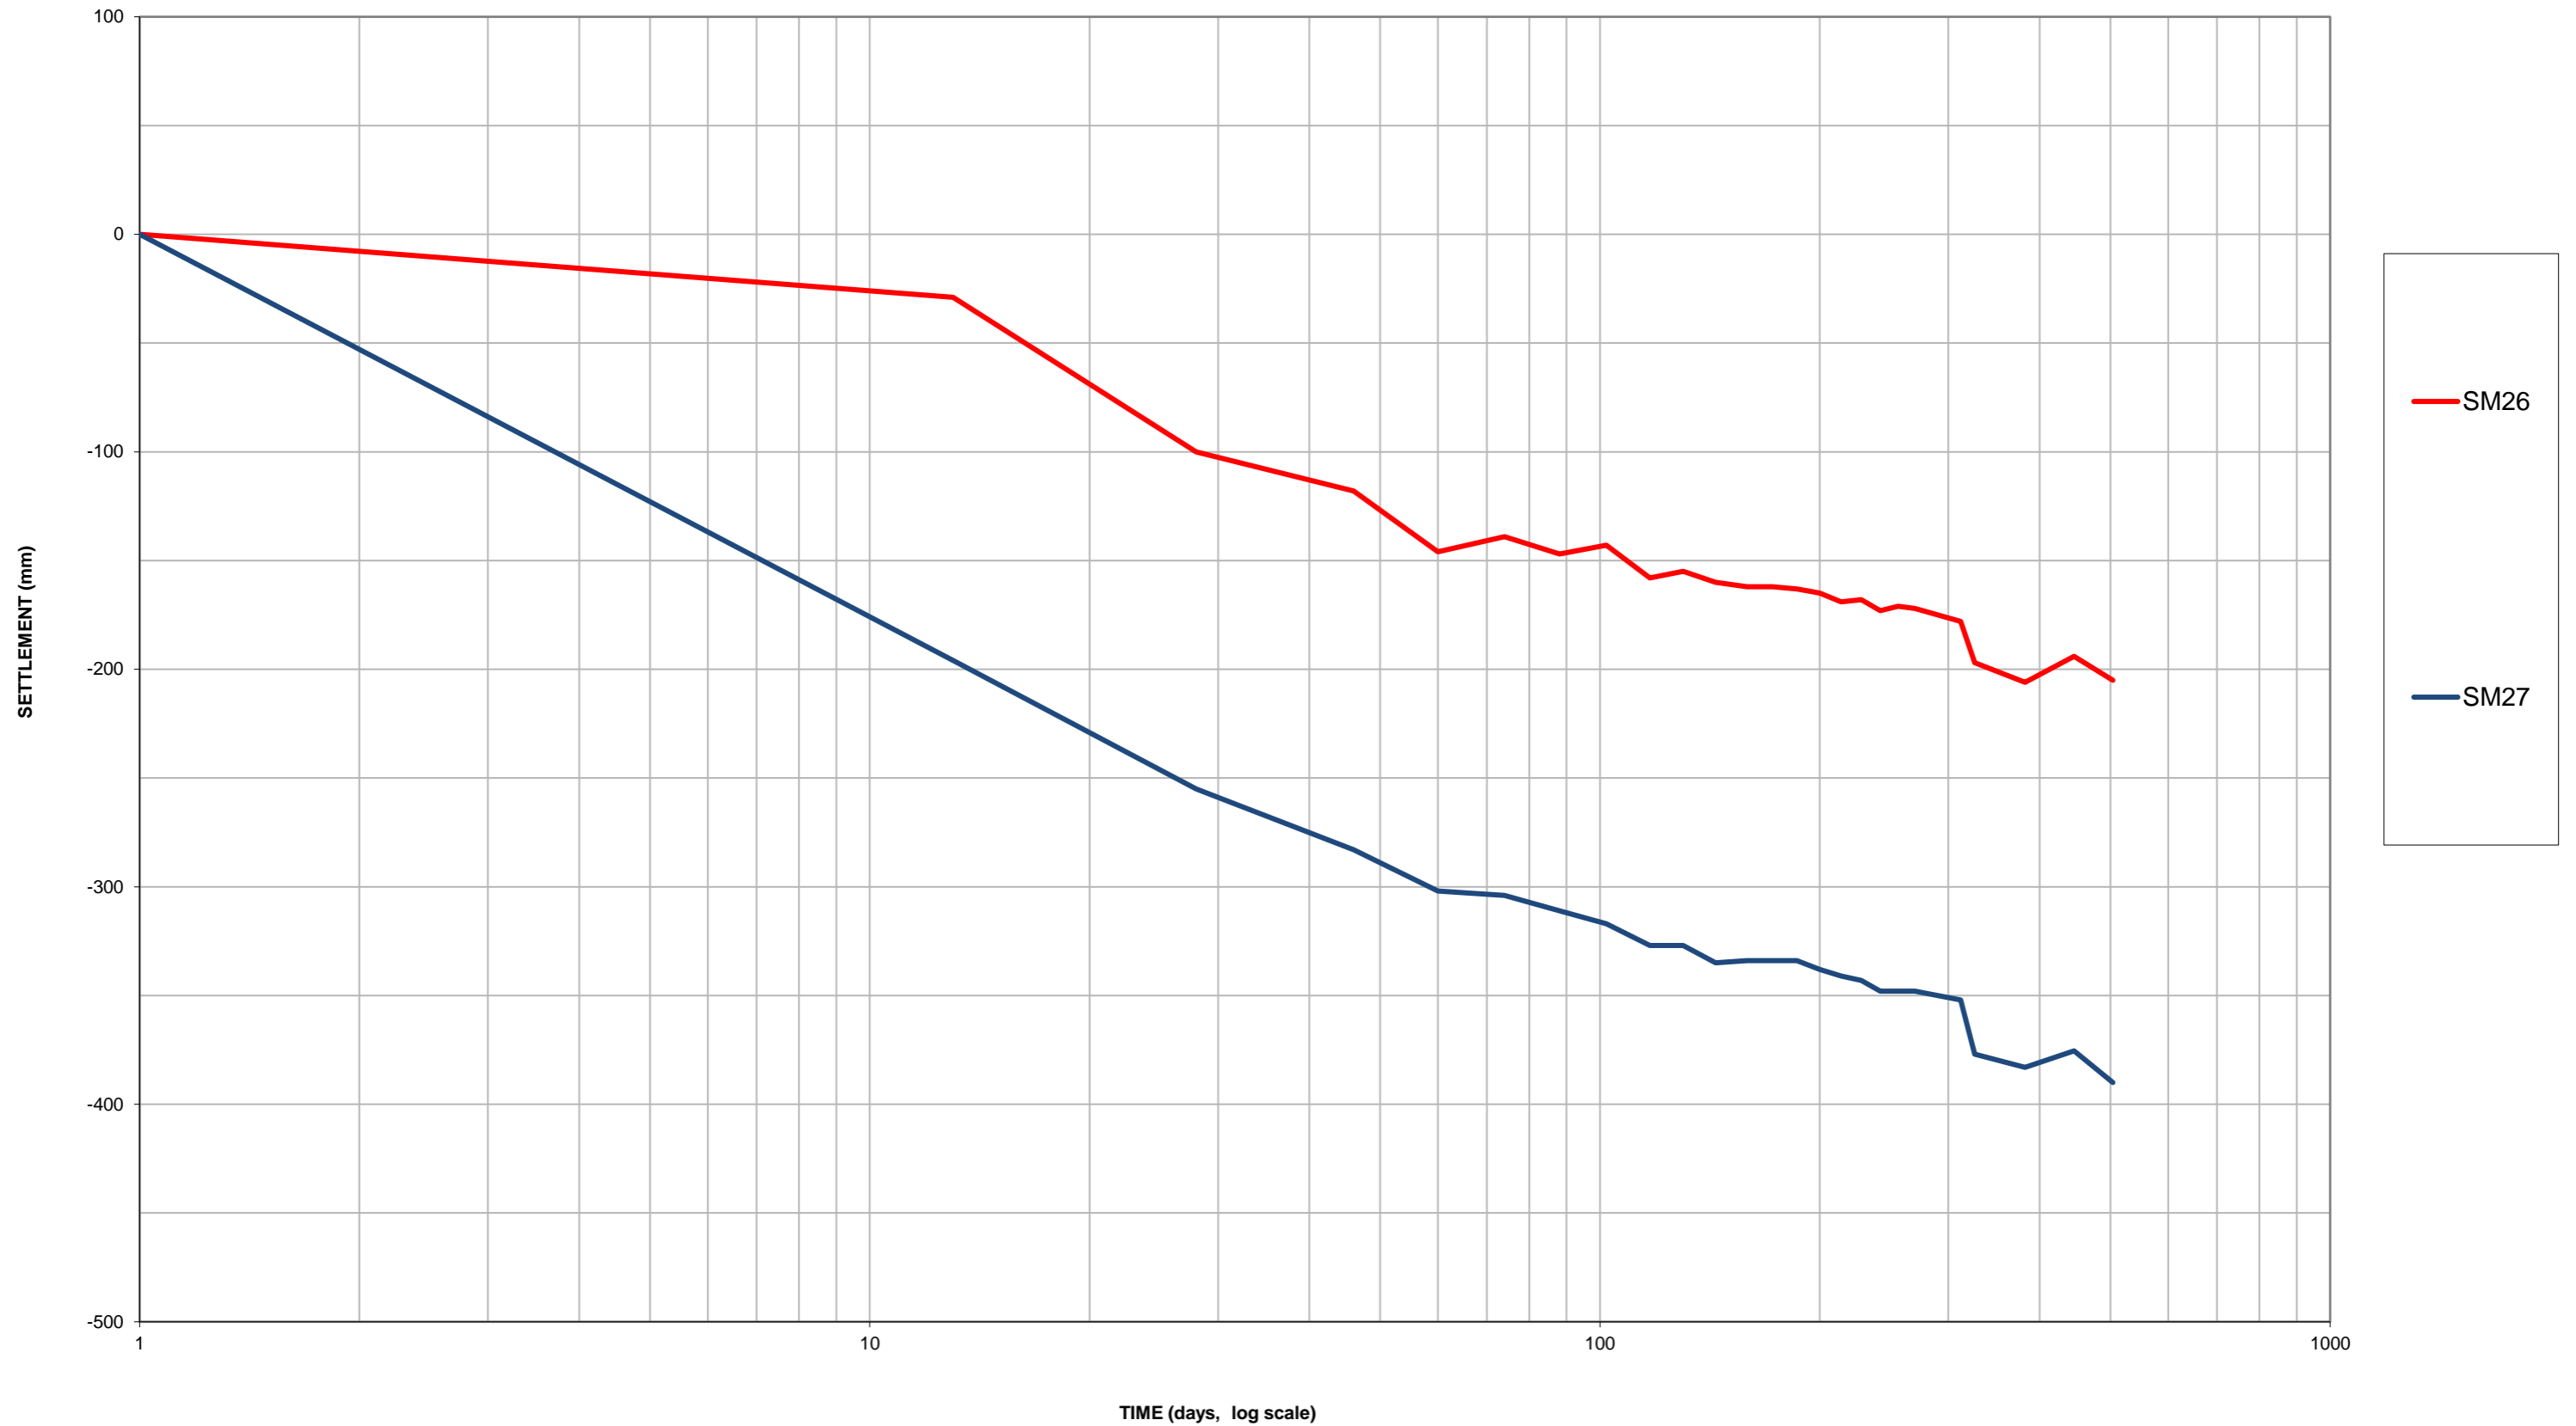
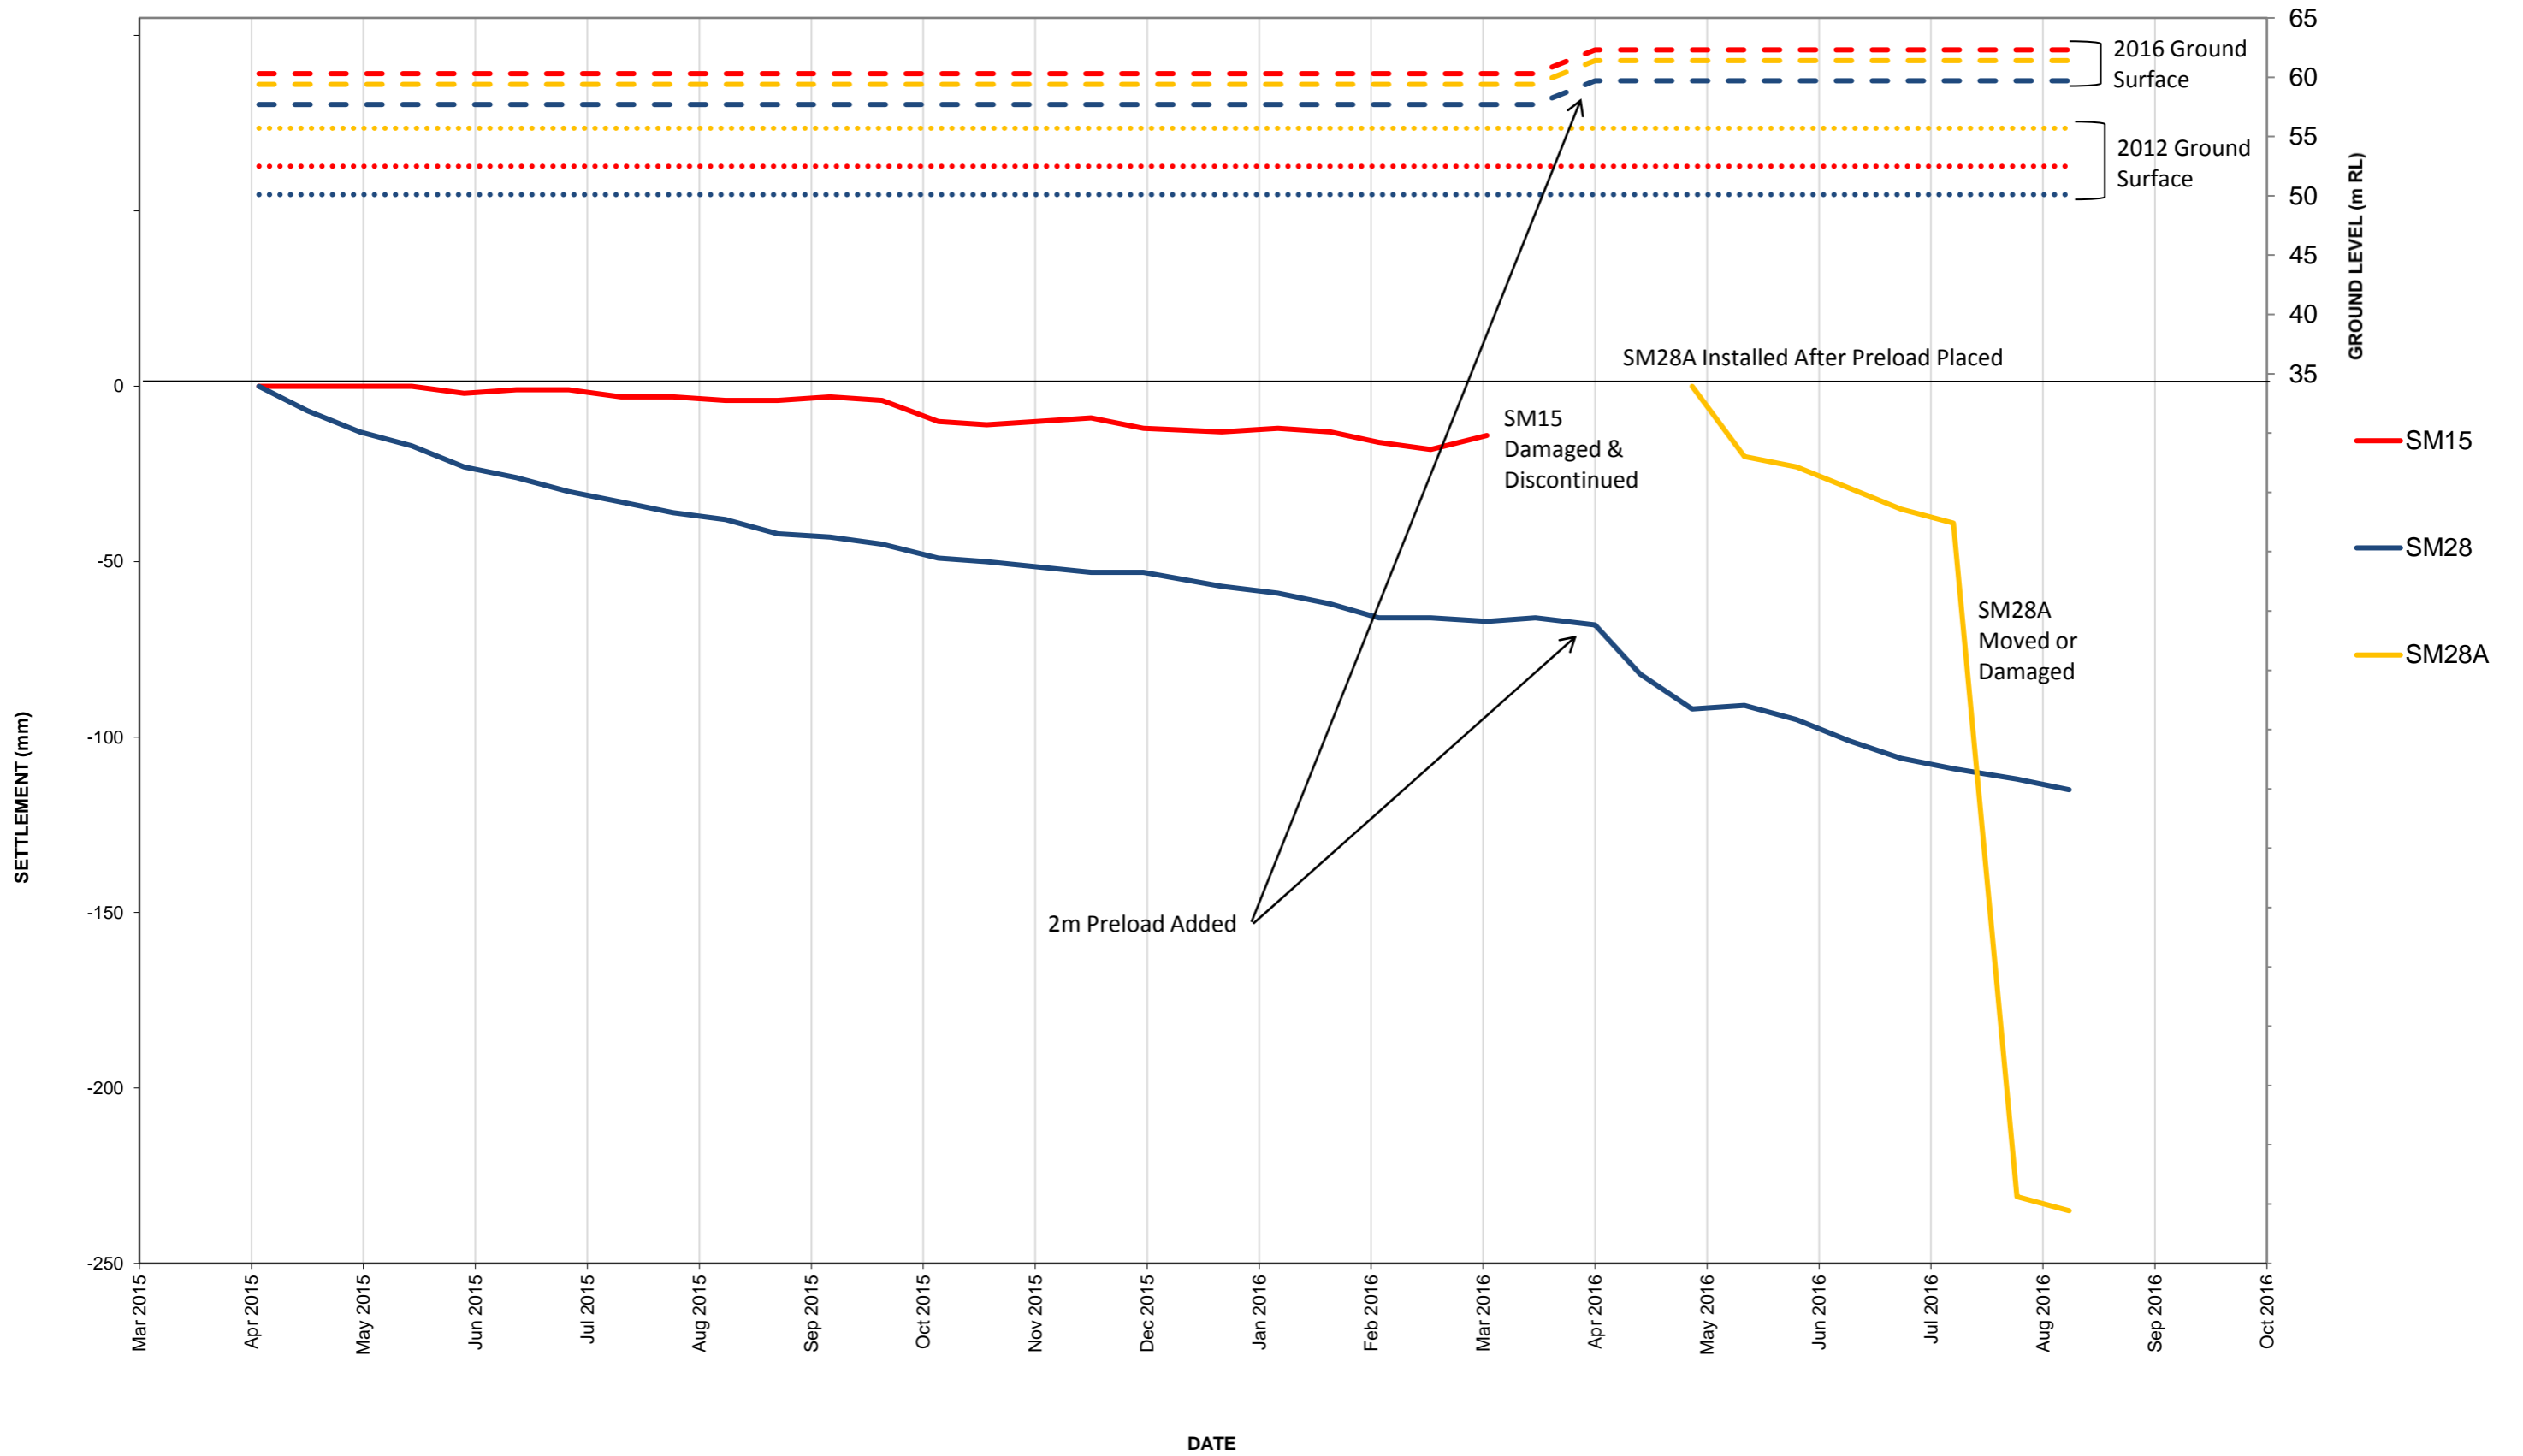
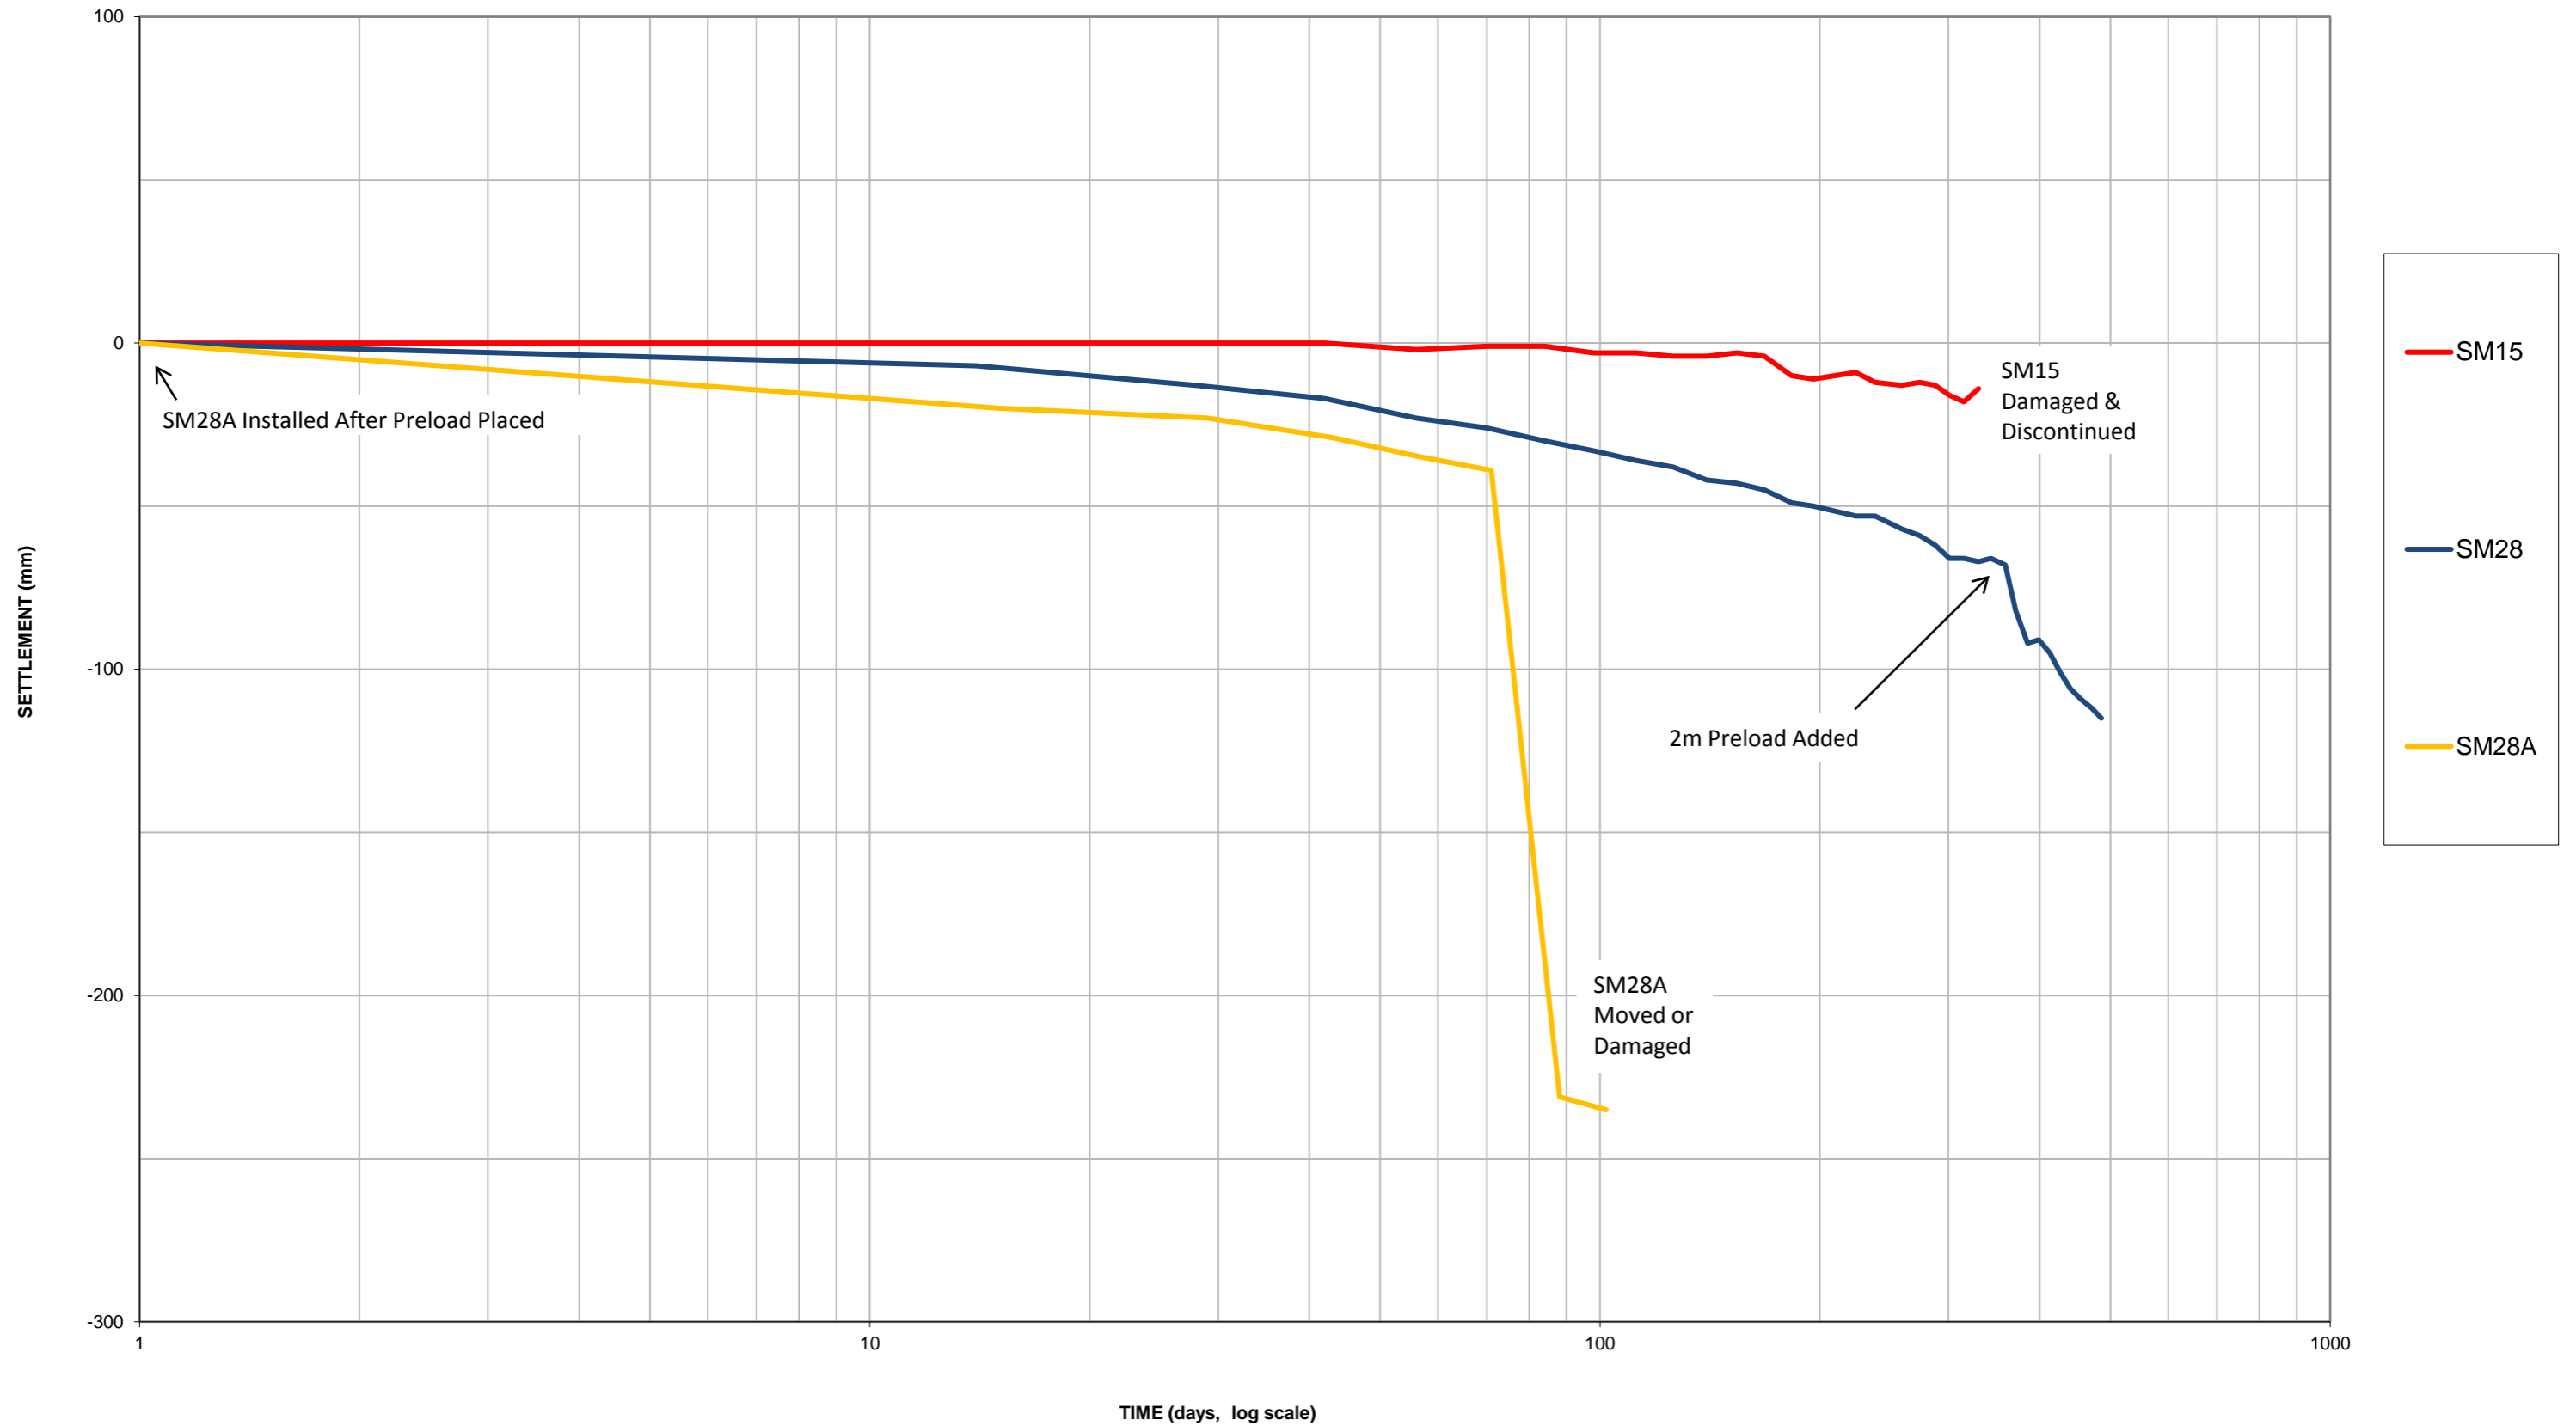
## **Appendix F – Static Settlement Results**

The data show the majority of consolidation settlement below the filling occurred within 2 to 3 months of earthworks being completed. Thereafter, settlement entered a long term 'creep' phase. Extrapolating the data out for a period of 50 years indicated that lots in this area may be affected by up to 100mm of future creep settlement over the assumed life of the proposed dwellings. However, differential settlements within the affected lots would be expected to be within the allowable range recommended by MBIE (i.e. 25mm/6m length), provided additional fill does not exceed 0.6m.

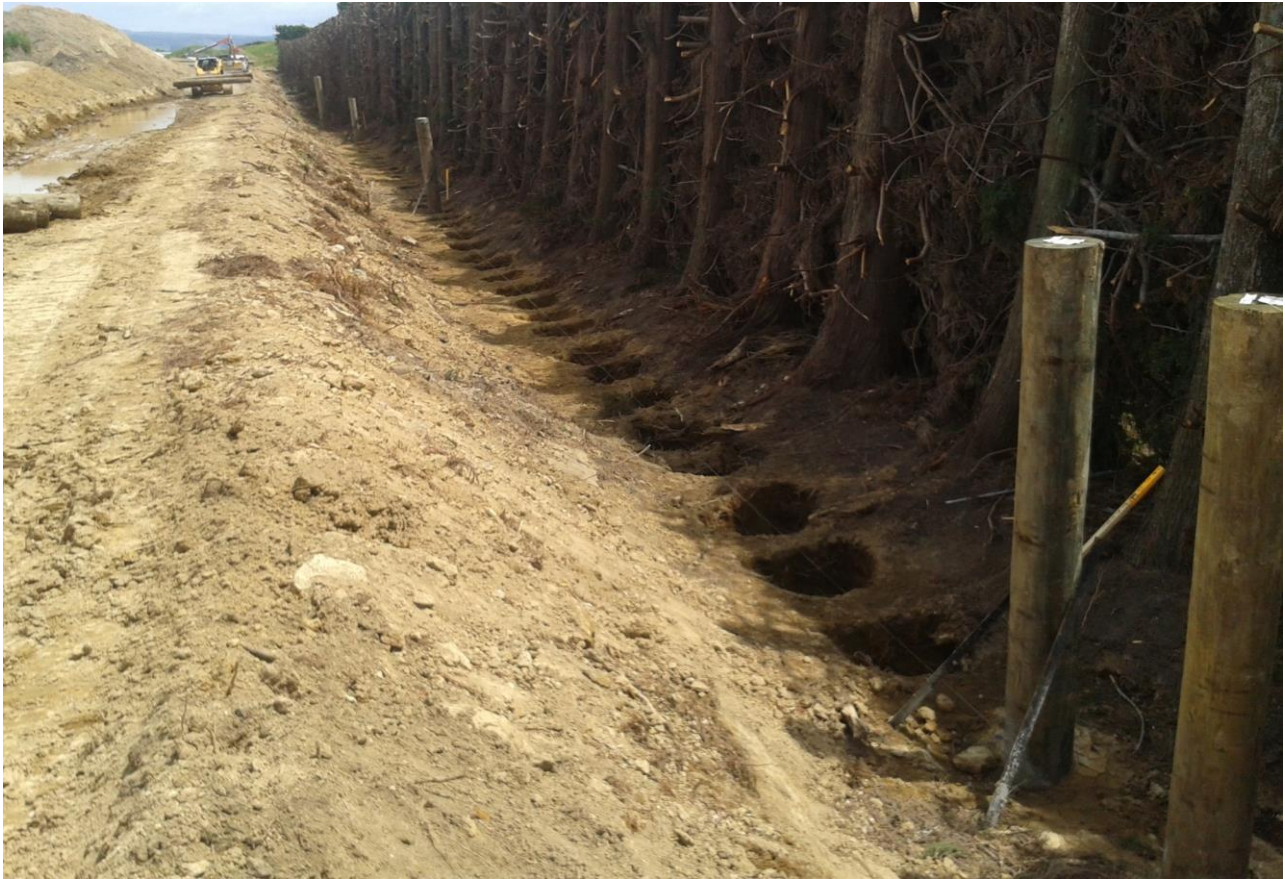
Photograph 1: Photo taken on the 10/11/16 of predrilled Pile holes 47 to 126.

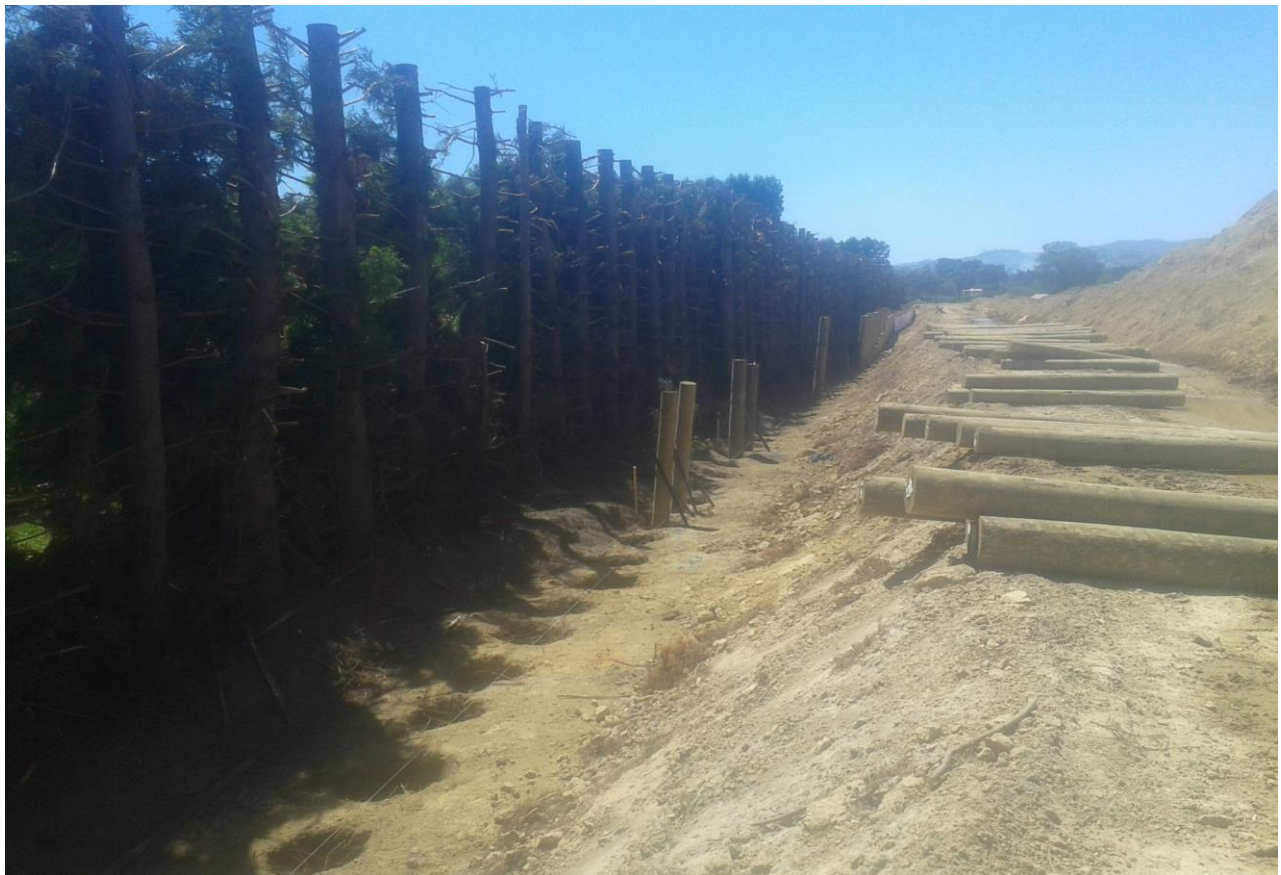
Photograph 2: Photo taken on the 22/11/16 of the placement of piles.

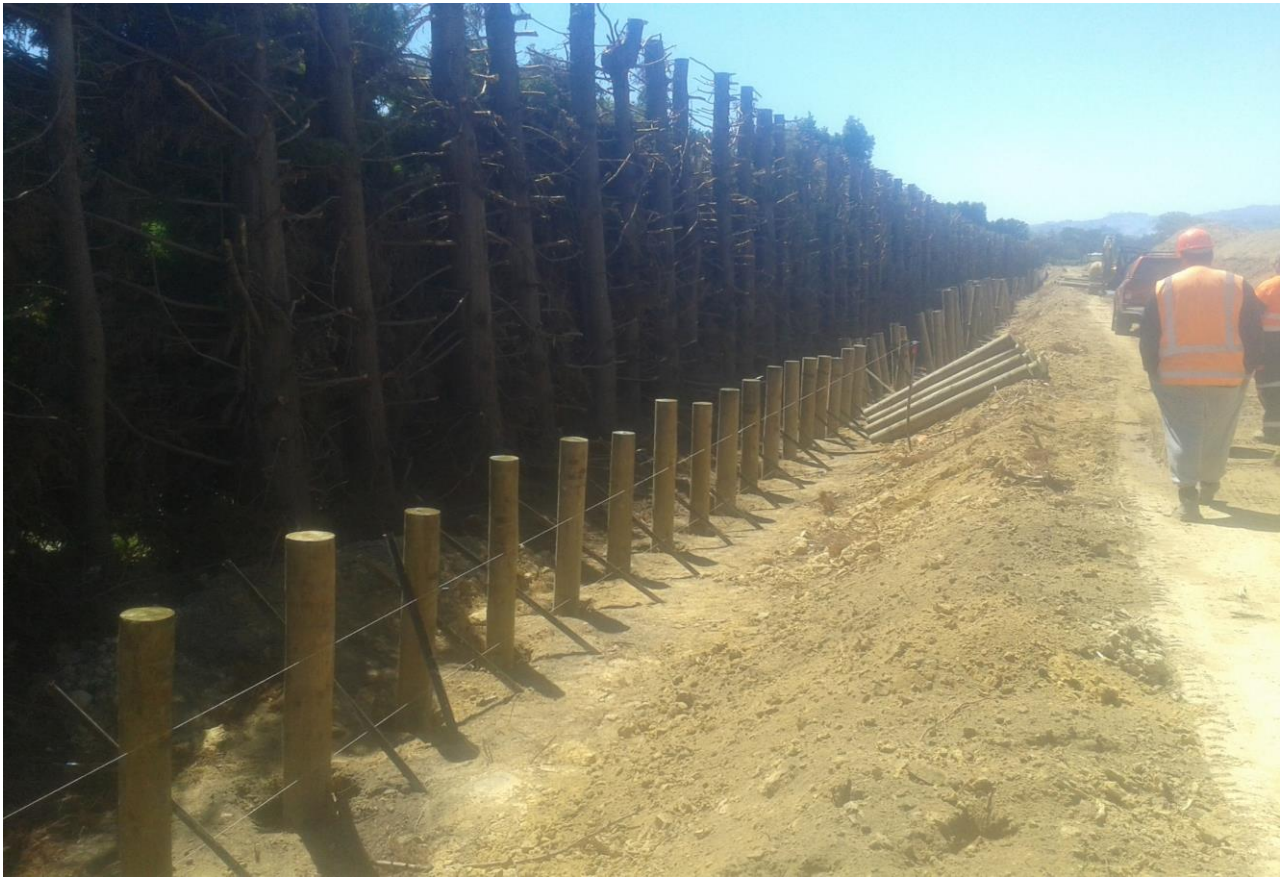
Photograph 3: Photo taken on the 22/11/16 of the final placement and alignment of retaining wall piles.

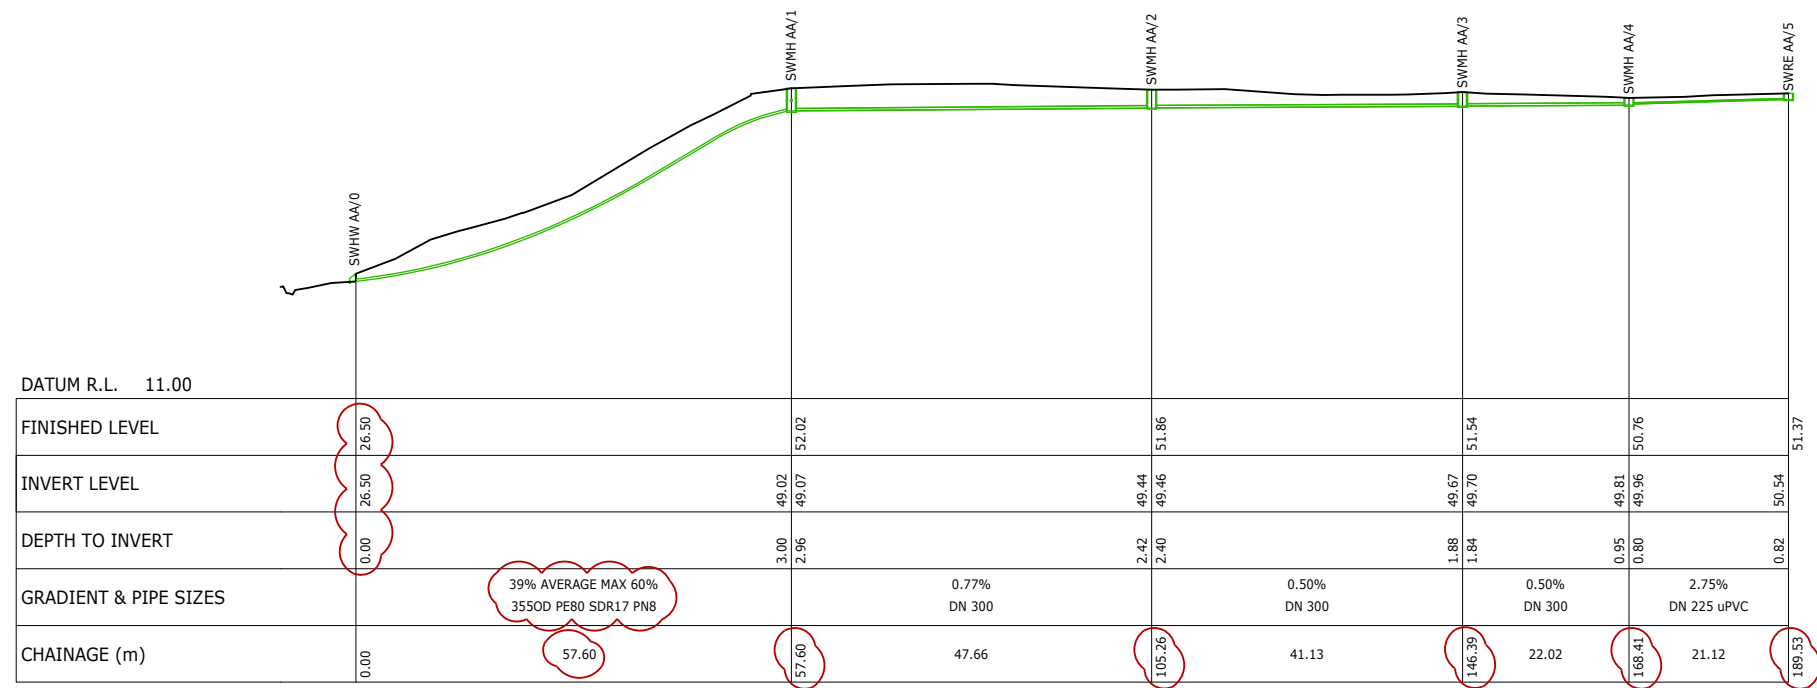
**STORMWATER LINE AA LONGITUDINAL SECTION**

A copy of Harrison Grierson's design drawings for the pipeline is included in Appendix G. Based on our observations during drilling and as-built survey information from Harrison Grierson, we consider the pipeline has been installed along an appropriate alignment. The survey data indicate the pipe is at least 3.0m deep below the existing ground surface as recommended.

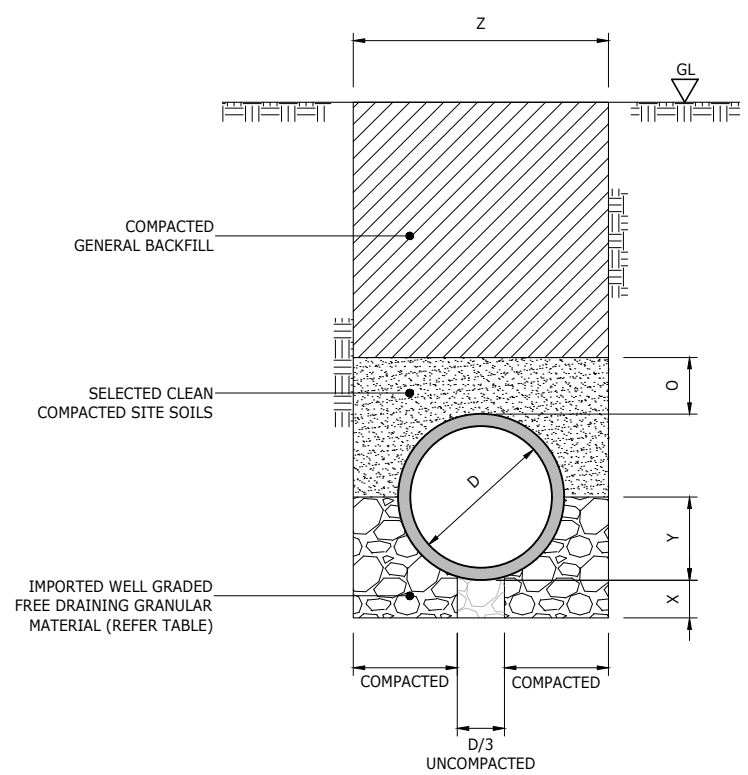
**CONCRETE PIPE BEDDING**  
SCALE NTS

GRADING FOR IMPORTED BEDDING	
SIEVE SIZE	% ALL PASSING
19.00	100
2.36	100 - 50
0.60	90 - 20
0.30	60 - 10
0.15	25 - 0
0.08	10 - 0

BEDDING DETAILS CONCRETE PIPES				
PIPE SIZE (mm)	X	Y	Z	O
300	100	110	665	150

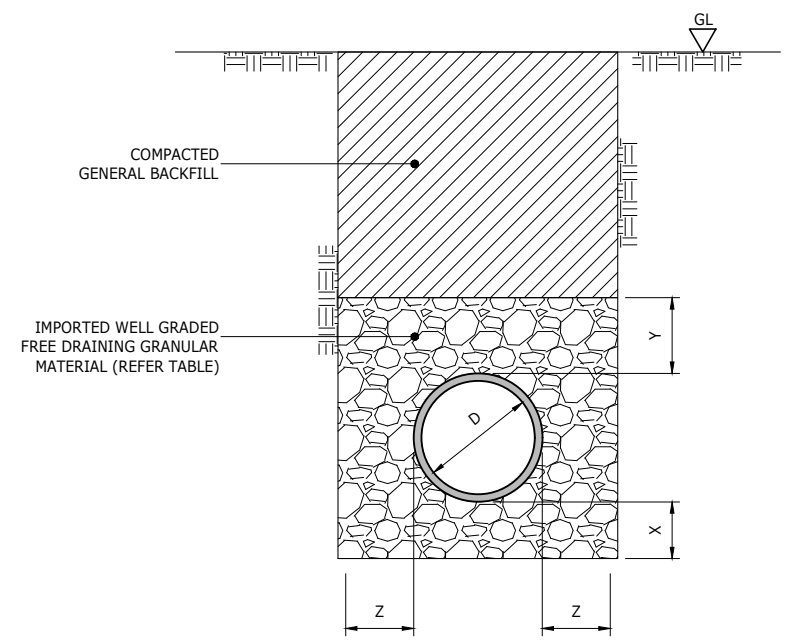
**PLASTIC PIPE BEDDING**  
SCALE NTS

BEDDING DETAILS uPVC PIPES			
PIPE SIZE (mm)	X	Y	Z
100	75	100	100
150	75	100	100
