Project: GENZTAUC13086AF - The Lakes Stage 3
Location: The Lakes, Pyes Pa

Engineering Log - Cored Borehole

client: **THE LAKES LIMITED (2012)**
 principal:
 project: **THE LAKES STAGE 3 CONSTRUCTION**
 location: **WESTERN BOUNDARY OF LOT 01**

Borehole ID: **MH3A-01**
 sheet: 2 of 5
 project no: **GENZTAUC13086AF**
 date started: **17 Nov 2014**
 date completed: **17 Nov 2014**
 logged by: **SLC**
 checked by: **RBT**

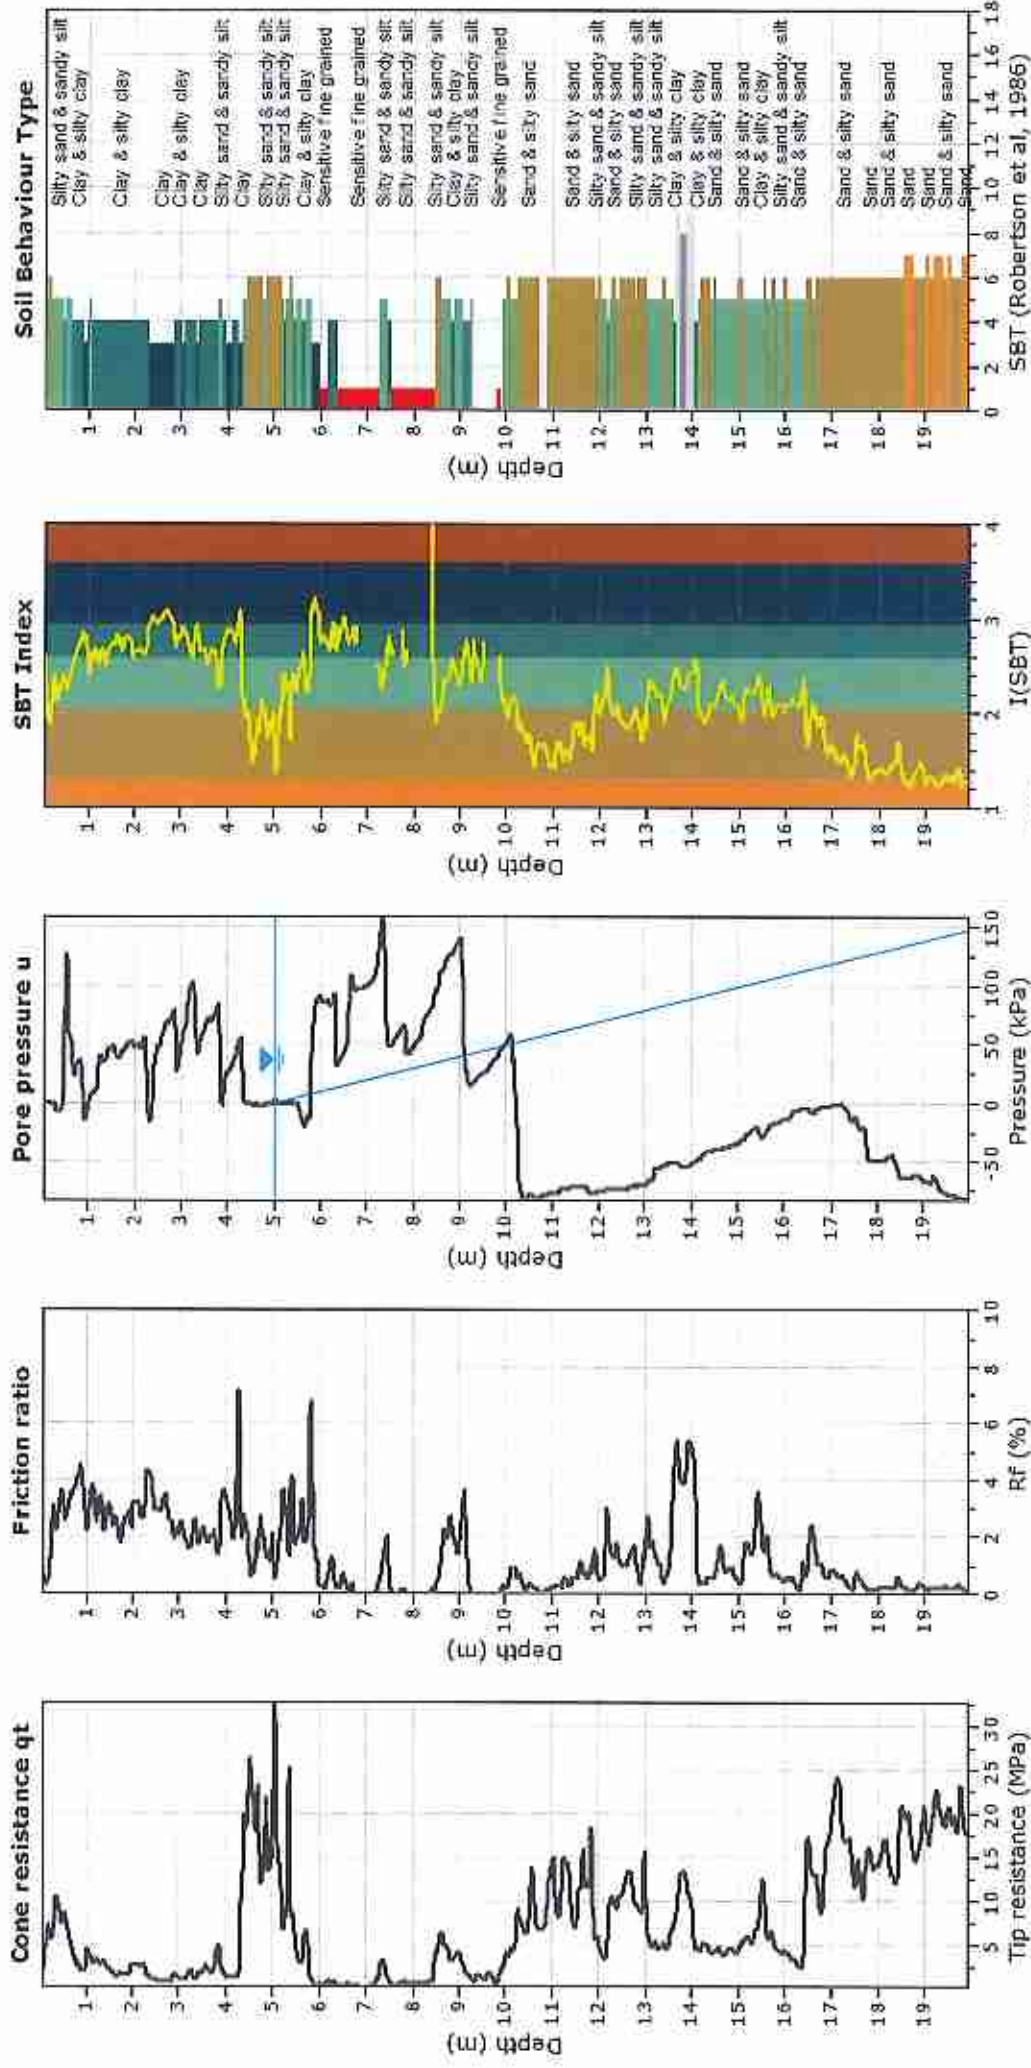
- SBT legend**
- 1. Sensitive fine grained
 - 2. Organic material
 - 3. Clay to silty clay
 - 4. Clayey silt to silty clay
 - 5. Silty sand to sandy silt
 - 6. Clean sand to silty sand
 - 7. Gravely sand to sand
 - 8. Very stiff sand to clayey sand
 - 9. Very stiff fine grained
