Loss of control involving Robinson R44, VH-WOH

20 km south-west of Mudgee, New South Wales | 9 December 2012

ATSB Transport Safety Report
Aviation Occurrence Investigation
AO-2012-165
Final – 26 September 2013

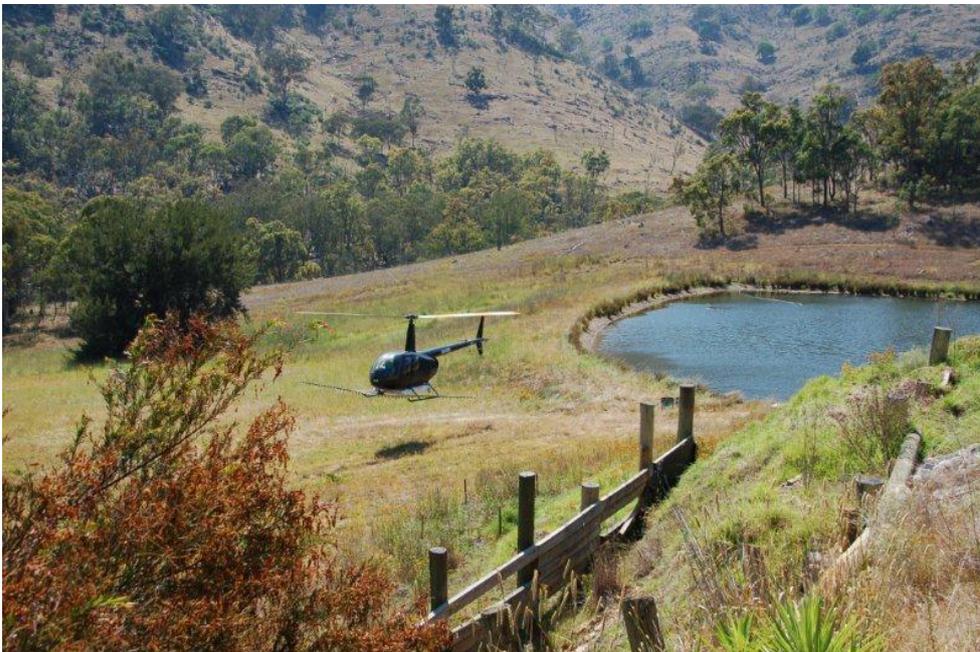
Figure 1: Helicopter landing at the refilling station

At about 0800 Eastern Daylight-saving Time¹ on 9 December 2012, a pilot commenced weed spraying operations on a property 20 km south-west of Mudgee, New South Wales in a Robinson R44 Raven I helicopter, registered VH-WOH (WOH). The intention was to conduct spraying activities on the property followed by further spraying on a neighbouring property. The operation required a loader to remain at a refilling station established at a dam on the property to mix the required chemical prior to loading it into the helicopter (Figure 1). The owner from a neighbouring property was also located at the dam.

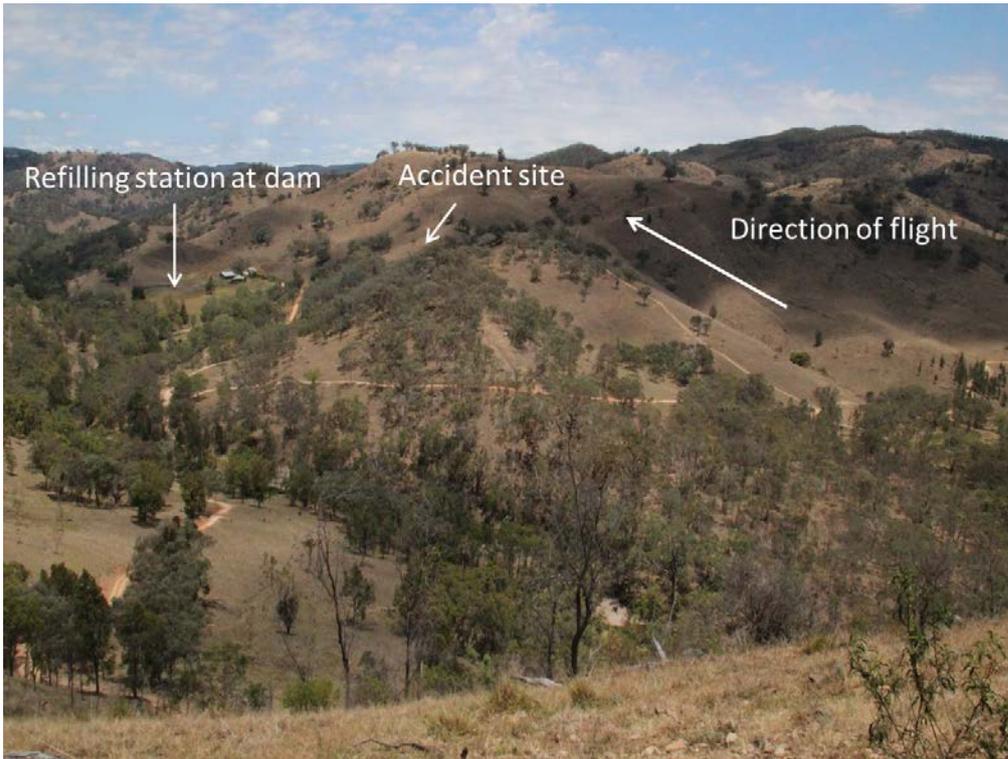
Figure 2: Overview of the property and accident site

At about 1015 the loader and neighbouring property owner became concerned that the helicopter had not returned and, along with the property owner, initiated a search. At about 1100, the helicopter was found on steep terrain about 450 m from the refilling station. The damage to the helicopter and disturbance of the surrounding area indicated that the helicopter contacted a tree before impacting the ground in a steep nose-down attitude with the right skid low (Figure 2, 3 and 4). The pilot was fatally injured and the helicopter seriously damaged.² There was no fire.

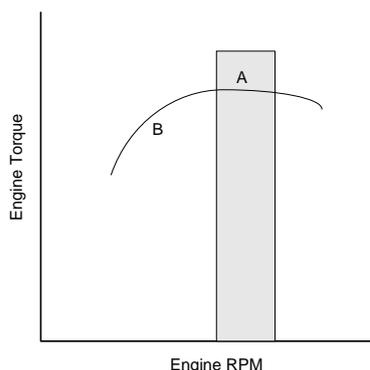
Figure 9: Typical piston engine torque - RPM characteristics⁹

The operation of a piston-engine helicopter within the engine's normal RPM range, shaded region 'A' in Figure 9, results in minimal variation in the available engine torque. However, as the engine RPM reduces below that operating range and into region 'B', there is an increasingly significant reduction in the available engine torque and power available to drive the rotor. In consequence, there can be an additional reduction in main rotor RPM.

Overpitching occurs when the main rotor RPM reduces to the point that the engine cannot produce sufficient power to overcome the increased drag on the rotor as a result of the pilot acting to maintain height. Once overpitching occurs, the decreased main rotor RPM results in increased coning and a decrease in rotor thrust. A descent will usually follow. If the pilot increases the collective to compensate, the situation rapidly deteriorates, resulting in a further reduction of main rotor RPM, increased coning of the main rotor blades, less lift and an increasing descent rate.

Recovery from overpitching requires the simultaneous application of more throttle (if there is more throttle available) and lowering of the collective control. This action decreases the blade pitch angle and reduces blade drag while maximising engine power in an effort to increase main rotor RPM. This may be counter intuitive to the pilot of a descending helicopter at low altitude.
