**ATSB TRANSPORT SAFETY REPORT**  
Aviation Occurrence Investigation  
AO-2009-068  
Final

**Operational event**  
**132 km west of Horn Island Aerodrome**  
**Queensland**  
**9 November 2009**  
**VH-EMZ**  
**Bell Helicopter 412**

Operational event – 132 km west of Horn Island Aerodrome, Queensland – 9 November 2009  
VH-EMZ, Bell Helicopter Company 412

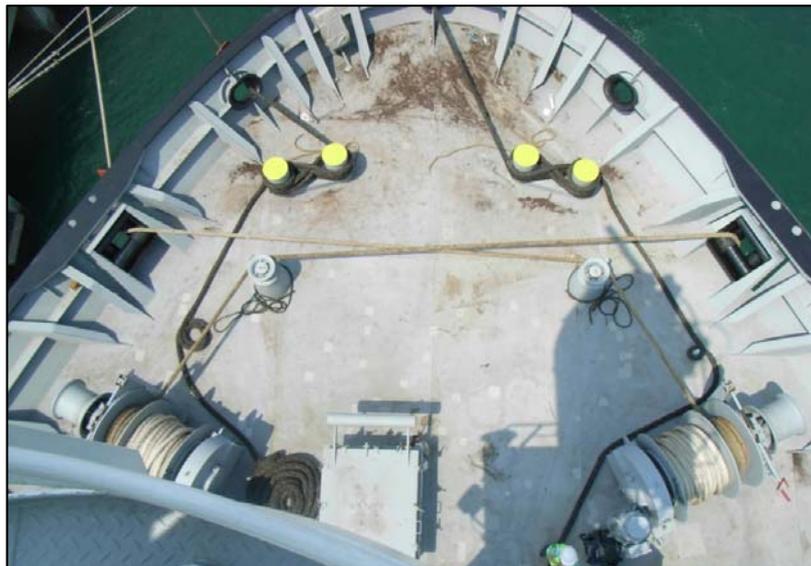
**Figure 3: *Maersk Duffield* forecastle, as seen from the radar scanner platform<sup>5</sup>**

Prior to departure from Horn Island, the crew were informed by the RCC that the ship's crew were not familiar with helicopter operations and that there was no area on the ship suitable for the helicopter to land. The RCC further advised that only the forecastle area (Figure 3) was suitable for winching operations, and the following details of the intended winching area were provided:

winch area: forecastle of the ship, dropping area is located ahead from forward mast [foremast] (16.2 m high), horizontal clearance from mast on deck is about 8-9 meters, in this area there are no obstructions higher than 1.5 meters.

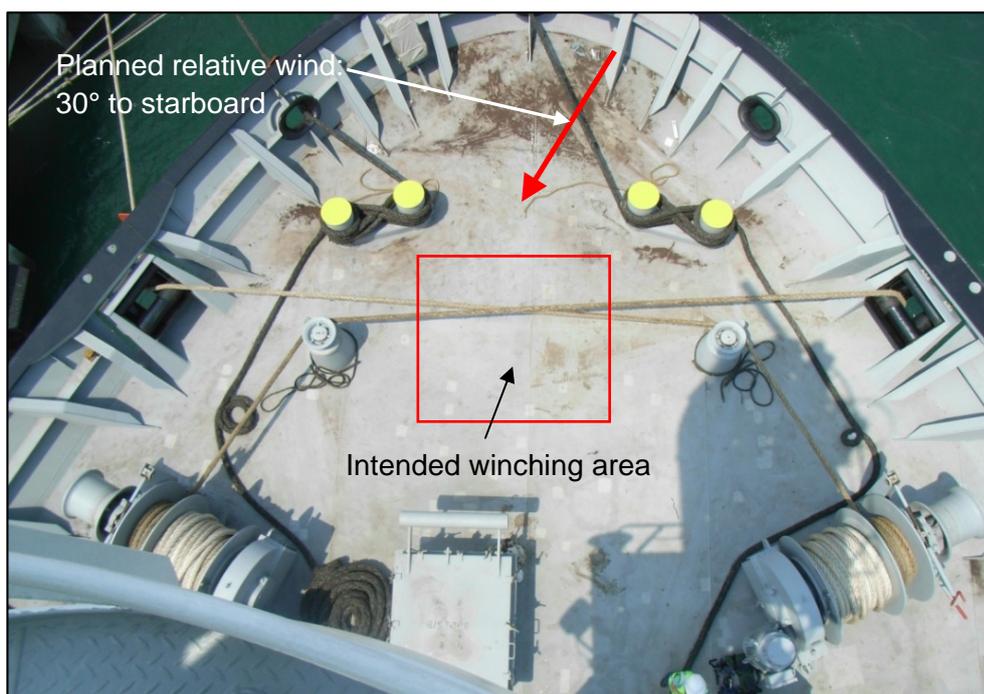
**Figure 4: Planned winching area<sup>9</sup> and relative wind**

Following receipt of the information from the RCC, the pilot and the available two crew officers<sup>6</sup> discussed the procedure for retrieving the patient. A plan was developed to request the ship to manoeuvre to provide a relative wind<sup>7</sup> that was about 30° off the starboard side in order to provide the pilot with a visual reference of the ship (Figure 4). The ACO reported that, in order to reduce the overall time required to conduct the retrieval, the RCO suggested that he and the paramedic be winched together directly onto the forecastle.<sup>8</sup>

The decision to undertake the winch to the forecastle was made by the master. The other options available for consideration were the ship's bridge wings, the monkey island;<sup>22</sup> or the top of the containers on the deck. The bridge wings and monkey island were considered unsuitable because of the number of aerials and other obstructions present, and the height of the containers above the deck meant that they were not accessible by the ship's crew. The forward part of the forecastle was chosen because it was clear of obstructions and considered to be large enough for the operation to be carried out safely (Figure 4).

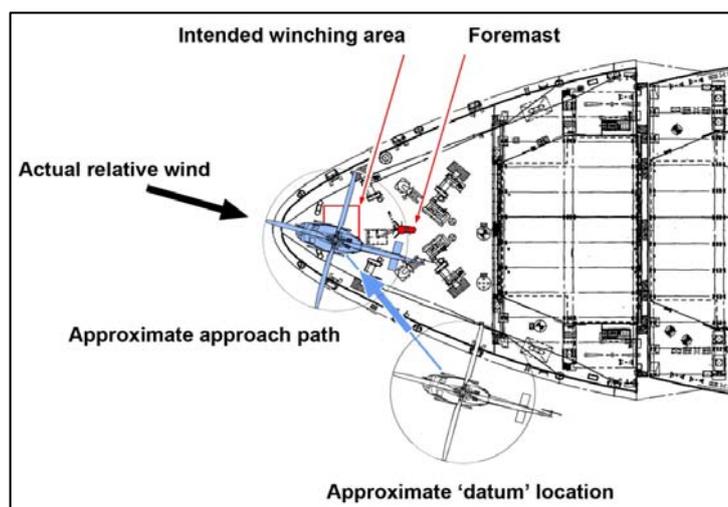
**Figure 5: Helicopter approaching the forecastle (shown to scale)**

At about 1550, the pilot approached the ship and terminated to the hover alongside at a position known as the 'datum' (Figure 5), from which the crew had a clear view of the winching area. While established at the datum with the helicopter facing into the relative wind, the pilot and ACO assessed the obstacles in the proximity of the winching area and confirmed that the helicopter had sufficient power margin<sup>10</sup> to conduct the winch. The pilot reported that although the helicopter airspeed indicator showed about 30 kts while hovering at the datum, there was no associated turbulence.

The ACO obtained permission from the pilot to commence the winch and began lowering the crew while the pilot began moving the helicopter towards the forecastle with the helicopter facing into the relative wind (Figures 5 and 6). A short time later, the pilot called ‘losing sight’<sup>11</sup> and the ACO commenced providing verbal guidance to allow the pilot to manoeuvre the helicopter towards the designated winch area. The pilot recalled that this guidance included instructions to descend as the helicopter approached the forecastle. The ACO reported that the crew had agreed to maintain about 20 ft vertical clearance from the foremast.

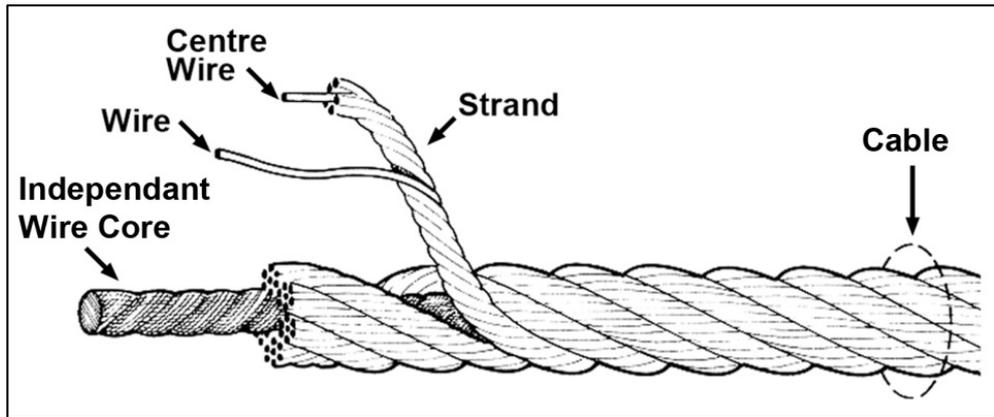
**Figure 15: Winch cable construction**

The 3/16<sup>th</sup> inch diameter winch cable comprised an independent wire core that was surrounded by a layer of central strands. The 19 strands each consisted of seven smaller diameter individual wires (Figure 15).

Wire cable can experience a significant reduction in strength when passed over a curved surface due to the inability of the individual strands and wires to reposition (Figure 15). This results in an increase in bending stresses, particularly within the larger diameter wires.

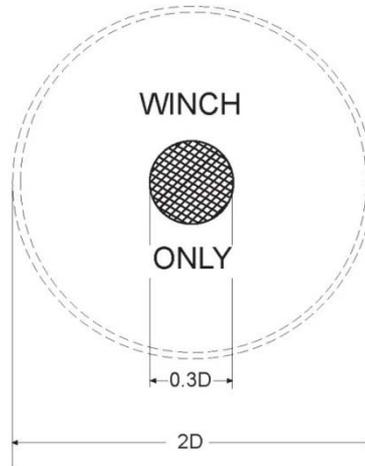
**Figure 21: International Chamber of Shipping-recommended helicopter winching area**

The dimension of a helicopter winching area is based on the overall length of the helicopter (labelled 'D'). The dimension of a generic winching area was listed as a circle with a diameter of 0.3D and of a manoeuvring area,<sup>20</sup> a circle with a diameter of 2D (Figure 21). In the case of a Bell 412 helicopter, that corresponded to a winching zone of 5 m diameter and a manoeuvring area of 34 m diameter.

*Maersk Duffield* is a large container ship, on which large open spaces required for helicopter operations did not exist. Consequently, any temporary winching area on board the ship could not comply with the winch zone and manoeuvring area dimensions contained in the ICS guide. This problem was recognised in the ICS guide, which provided assistance to ship's staff with regard to the selection of a suitable location on board to safely conduct helicopter winching operations. That was particularly the case in the event of an emergency, when the ICS guide allowed that:<sup>21</sup>

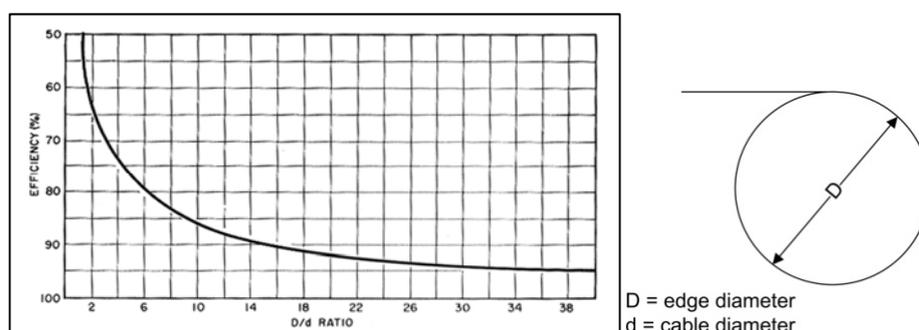
**Figure 22: Reduction in strength due to bending**

A cable that is bent about a surface of its own diameter will have less than 50% of its nominal strength. The strength loss depends on the severity of the bend, and can be expressed in terms of the  $D/d$  ratio; where 'D' is the edge diameter and 'd' is the cable diameter (Figure 22). Relatively small bend angles (less than  $45^\circ$ ) can still result in a significant loss of strength.
